St. Thomas' Vestry  
 East Elevation and Bell Tower Repairs/Restoration - Summary  
 March 15, 2020/February 6, 2022 (updated)

*The following historical summary was initially prepared in March of 2020 (pages 1 and 2) and has been updated for the subsequent evaluation of alternatives to repair the Bell Tower (pages 3 and 4).*

**Church Insurance Company of Vermont**  
**Claim Number: 35080**  
**May 23, 2017**  
**Page 9**

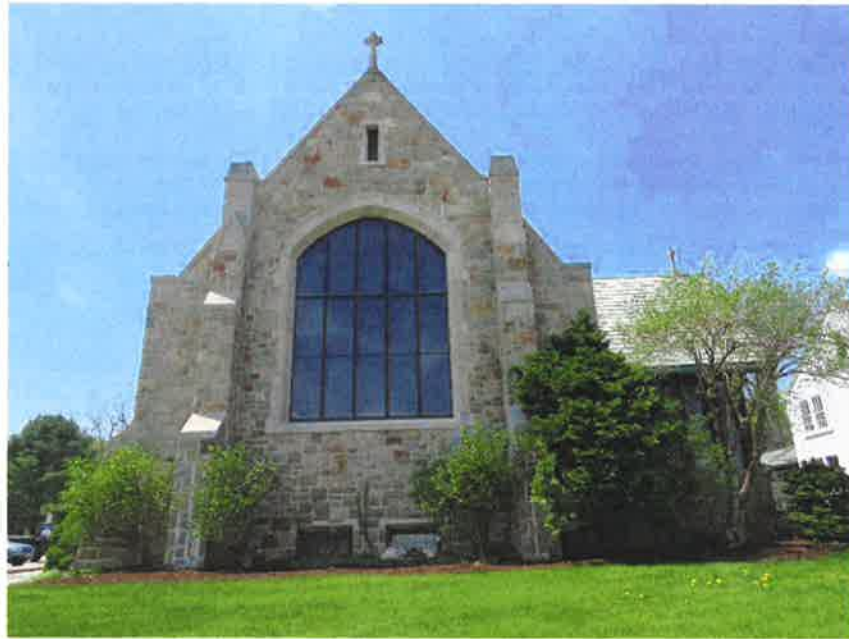
Photograph 1: The front of the church faces east toward Chestnut Street.

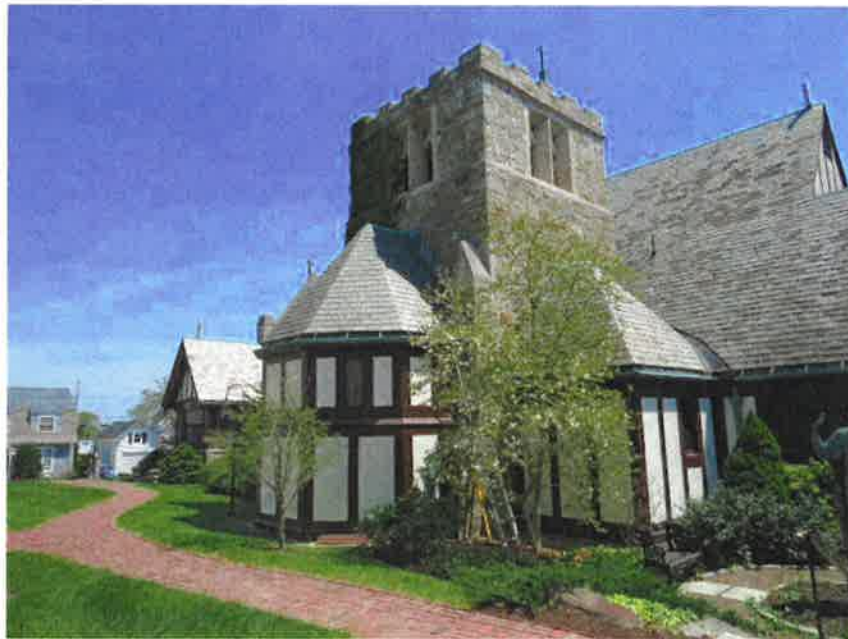
Photograph 2: The north (side) elevation of the church, the altar is north of the bell tower.

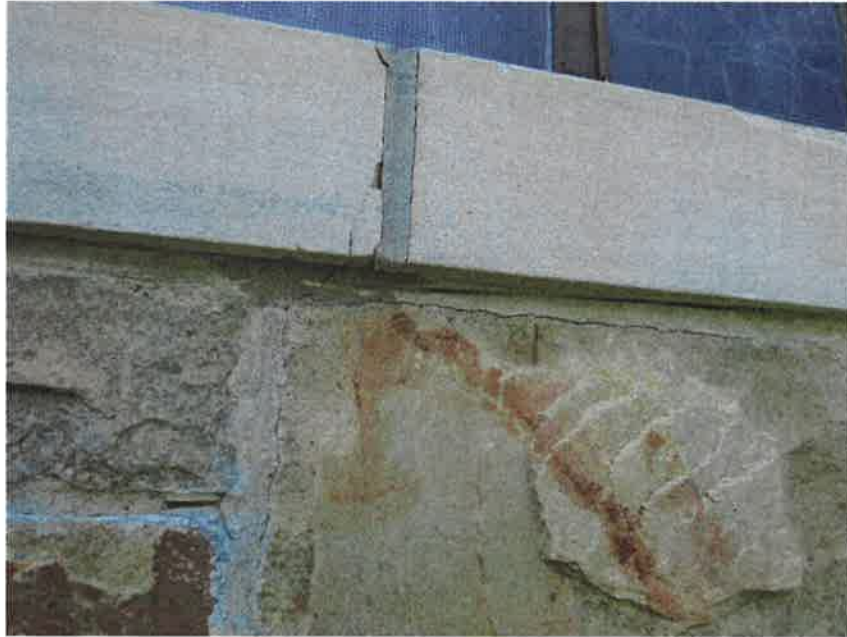
The walls of the church consist of stone and mortar masonry construction. The mortar is cracked throughout the church elevations (Photographs 3 and 4). The mortar is both light and gray in color (Photograph 5). Ivy is along the bottom portion of the east elevation. Piles of deteriorated and washed-out mortar and stone are below the bottom windows on the east elevation (Photograph 6). The stone surrounding the crawlspace window and the stained glass on the east elevation is cracked, broken, or deteriorated (Photograph 7). Paint is peeling and missing on the wood trim around the stained glass window on the east elevation. The wood trim along the top of the stained glass window on the east elevation is cracked and deteriorated (Photograph 8). A gap and deteriorated wood is around the crawlspace windows on the east elevation (Photograph 9). Deteriorated concrete is loose in the gap between the crawlspace windows and stone lintel. The stone approximately 3 feet below the stained glass window on the east elevation is bowing outward (Photograph 10). The stone surrounding the stained glass window on the east elevation is cracked and deteriorated (Photograph 11).

Photograph 3: The mortar is cracked throughout the church elevations.

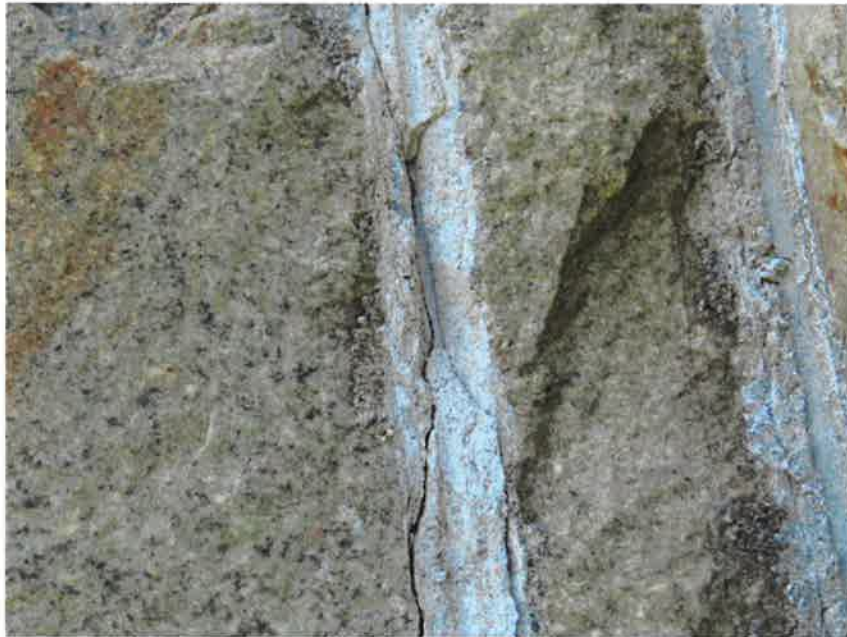
Photograph 4: The mortar is cracked throughout the church elevations.

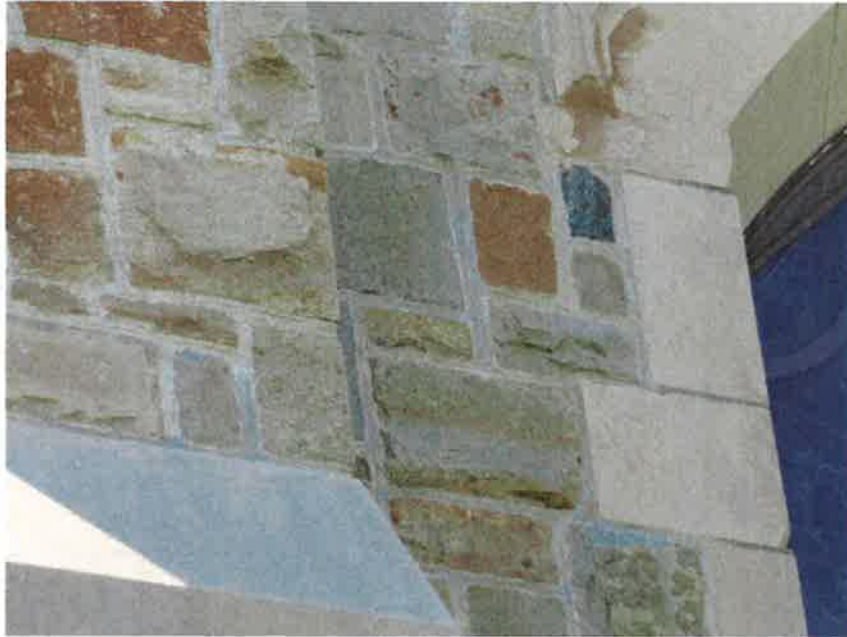
Photograph 5: The mortar is both light and gray in color.

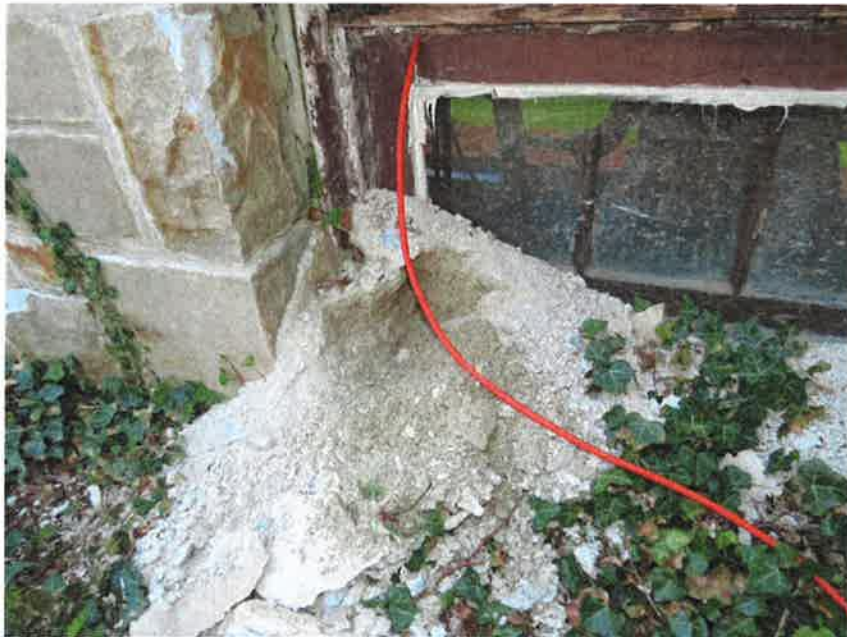
Photograph 6: Piles of deteriorated and washed-out mortar and stone are below the bottom windows on the east elevation.

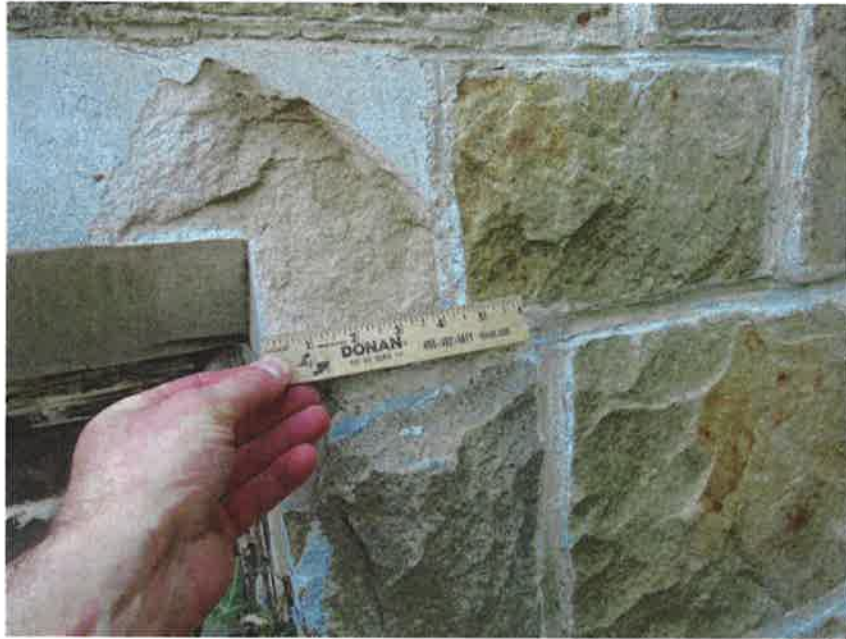
Photograph 7: The stone surrounding the crawlspace window on the east elevation is deteriorated and missing.

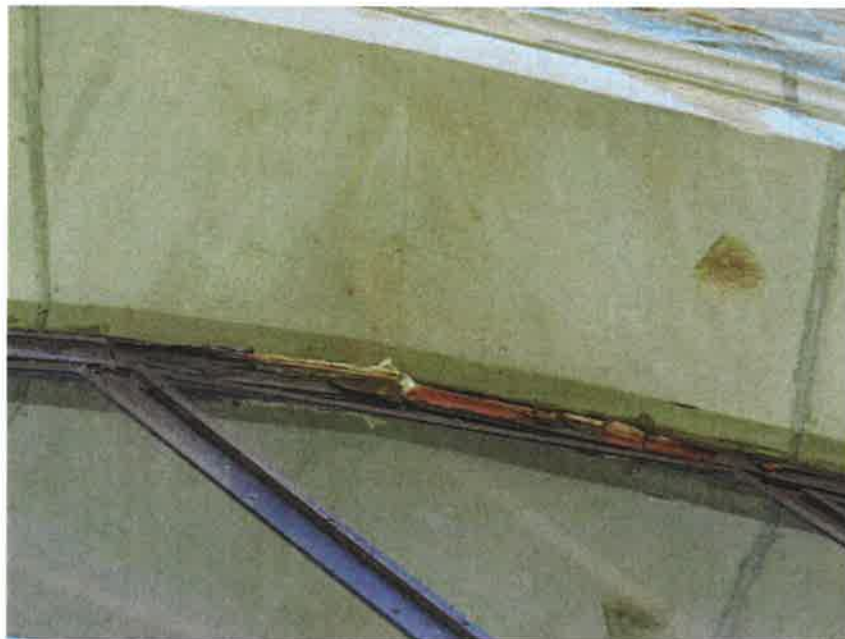
Photograph 8: The wood trim along the top of the stained glass window on the east elevation is cracked and deteriorated.

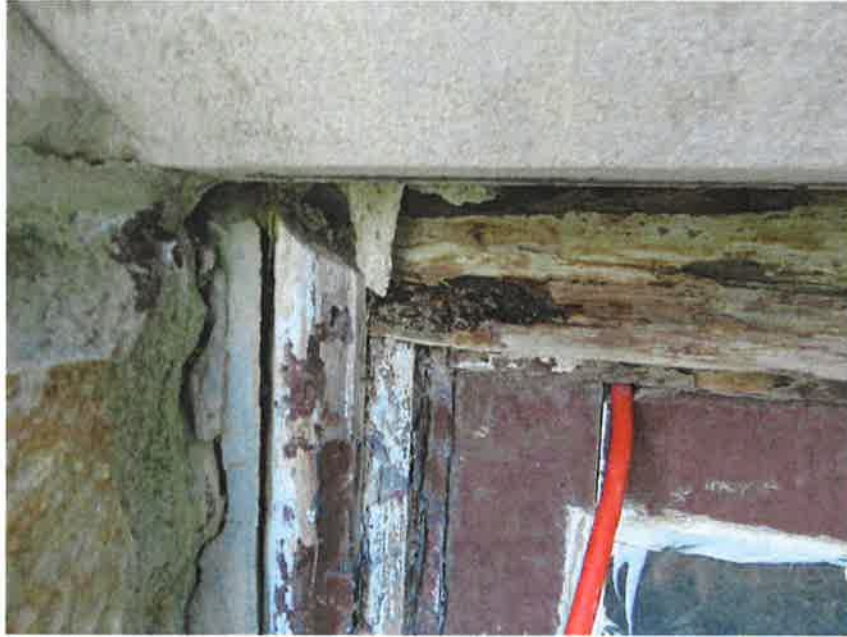
Photograph 9: A gap and deteriorated wood is around the crawlspace windows on the east elevation.

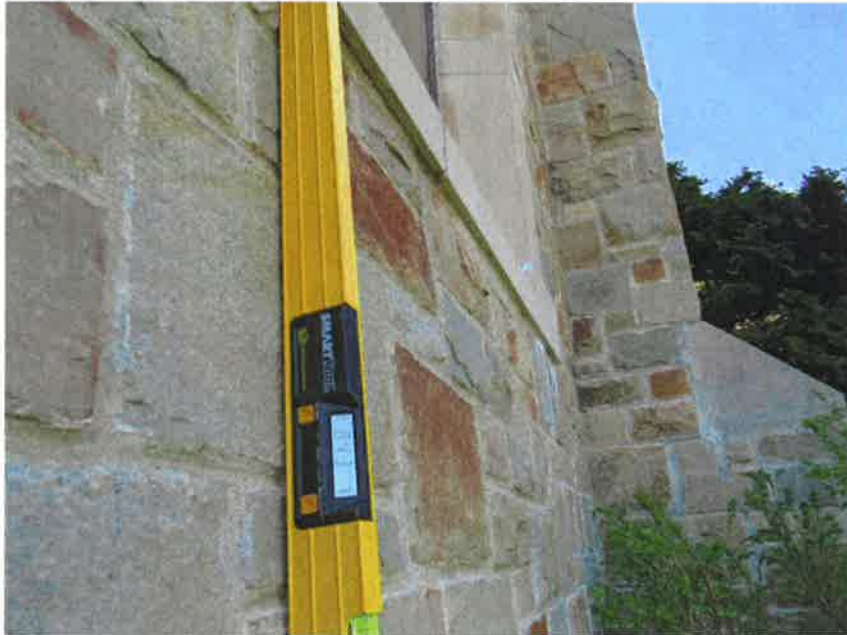
Photograph 10: The stone approximately 3 feet below the stained glass window on the east elevation is bowing outward.

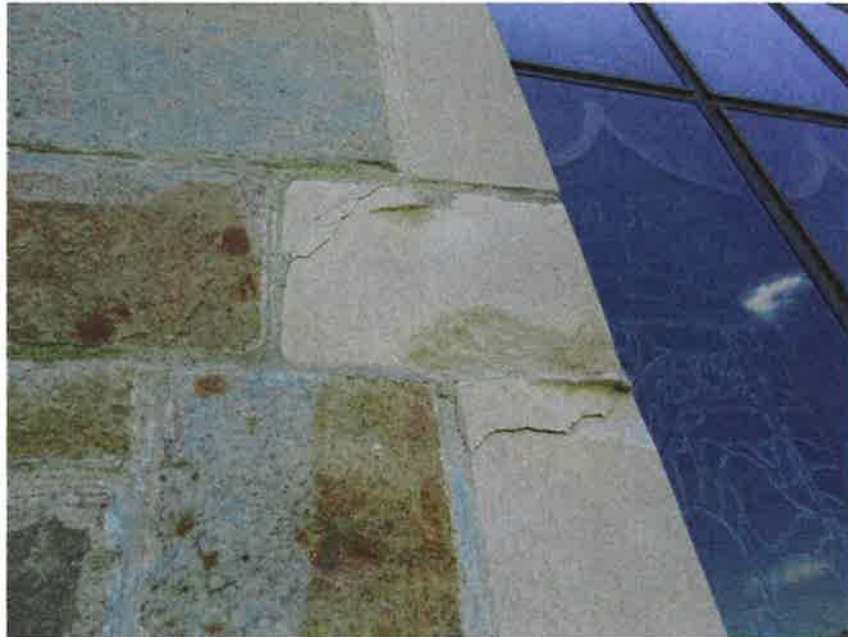
Photograph 11: The stone surrounding the stained glass window on the east elevation is cracked and deteriorated.

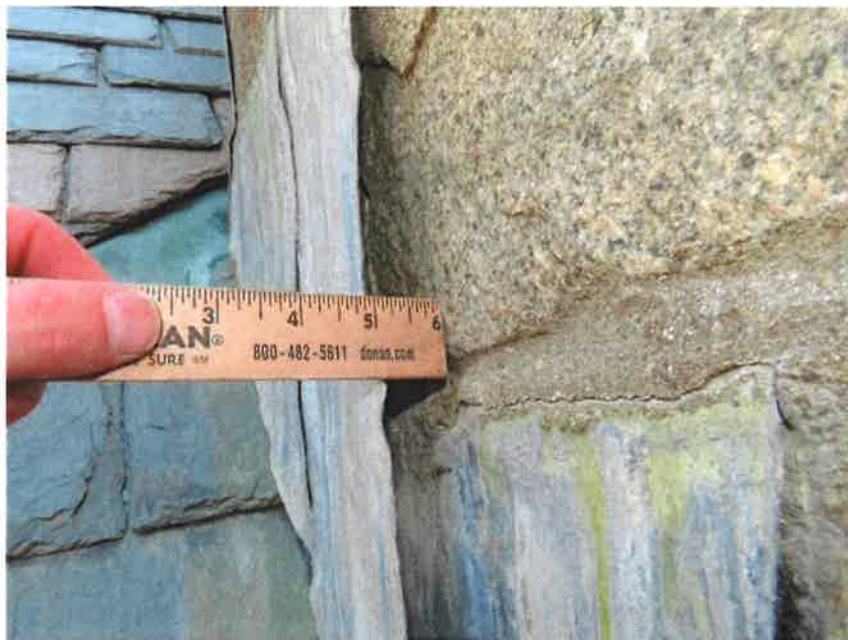
The stone mortar on the east and west elevations of the altar are cracked and deteriorated. The roof step-flashing on the sides of the altar are loose and a gap is between the flashing and the north elevation (Photograph 12). Sections of the concrete on the north elevation are removed and being replaced, as indicated by Mr. Glass (Photograph 13). White stains are on the stones on the east elevation below the bell tower (Photograph 14). Thick ivy covers the top of the bell tower. Water is leaching out of the stone on the east elevation of the bell tower (Photograph 15). The stones around the bell tower's east elevation window are cracked, displaced, and deteriorated (Photograph 16). The wood trim on the west

Photograph 12: The roof step-flashing on the sides of the altar are loose and a gap is between the flashing and the north elevation of the church.

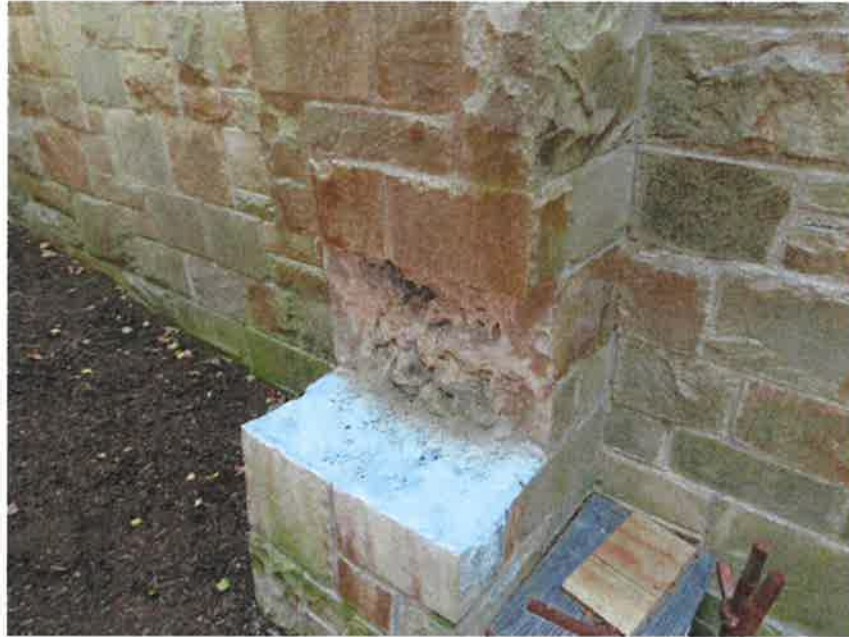
Photograph 13: Sections of the concrete on the north elevation is removed and being replaced.

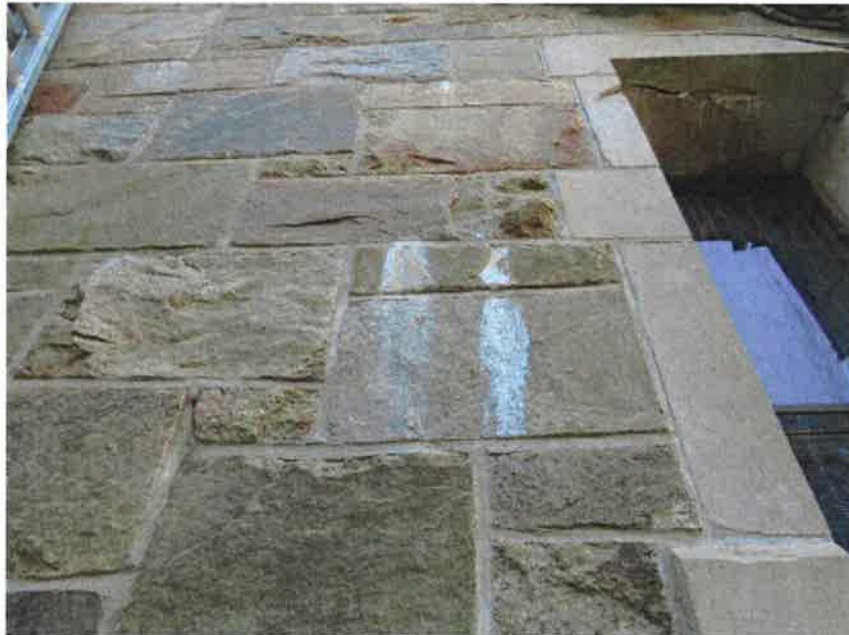
Photograph 14: White stains are on the stones on the east elevation below the bell tower.

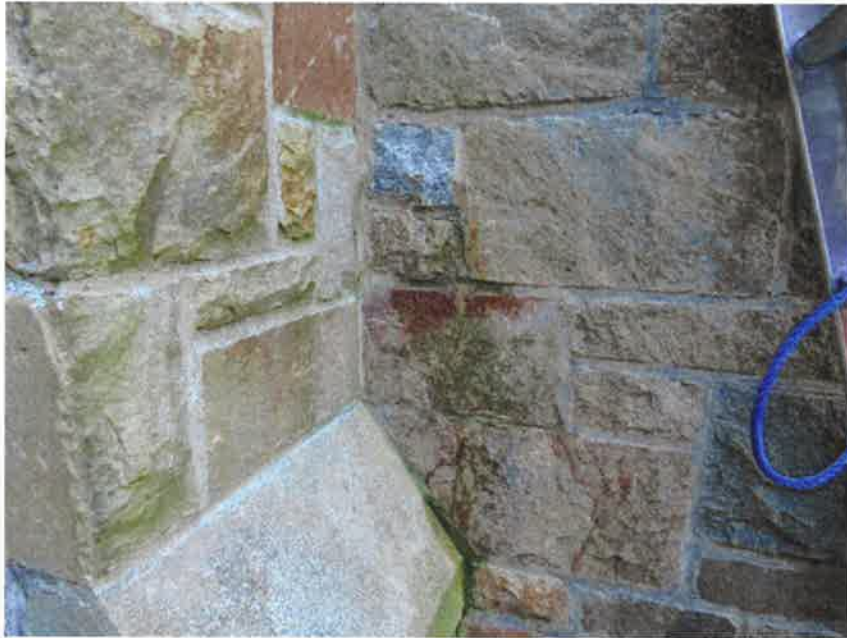
Photograph 15: Water is leaching out of the stone on the east elevation of the bell tower.

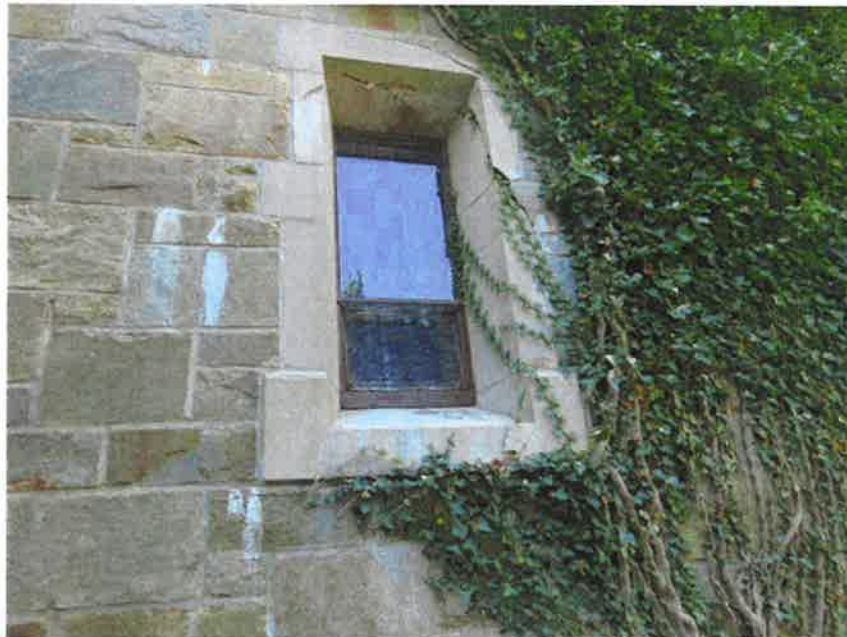
Photograph 16: The stones around the bell tower's east elevation window are cracked, displaced, and deteriorated.

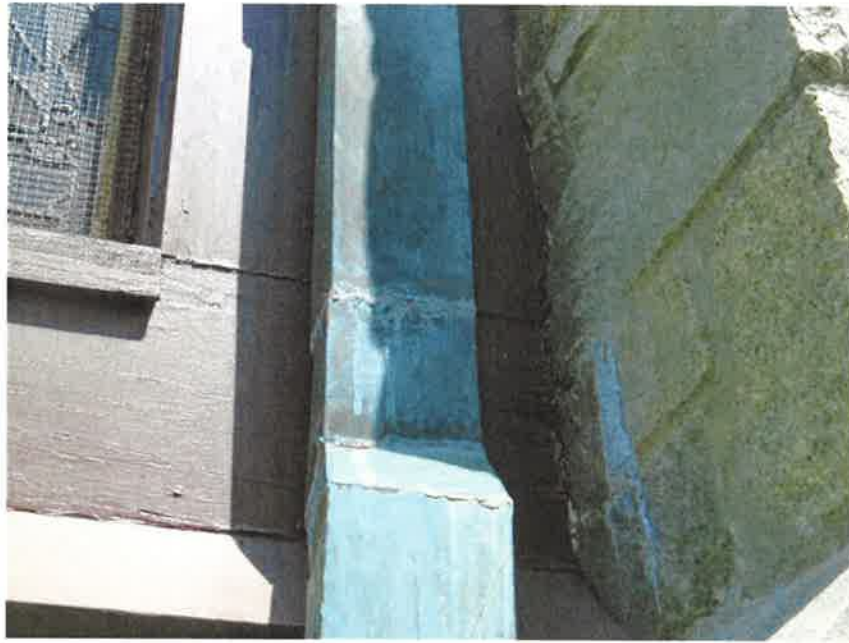
Photograph 17: The wood trim on the west elevation of the altar is rotted and a gap is between the wood and the stone.

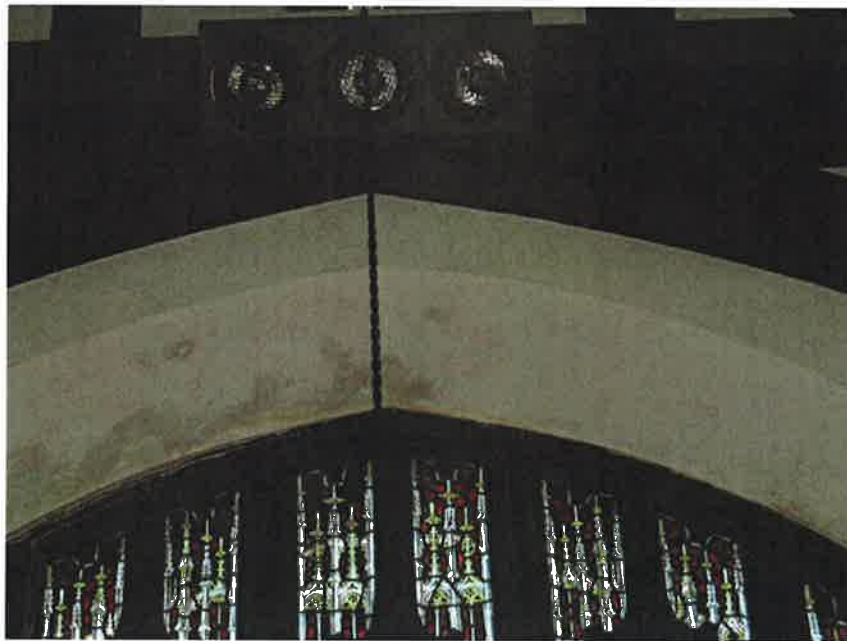
Stains, a white substance, and cracks are in the church below the east wall stained glass window, the north wall below the bell tower, and the southwest corner of the altar (Photographs 18 through 22). The floor and roof drains from the bell tower are within the wall and have no access. The photographs of the bell tower provided by Mr. Glass have wear and tear, deterioration, and water stains to the bell tower ceiling, wall, and floor.

Photograph 18: White substance and stains on the east wall of the church around the stained glass window.

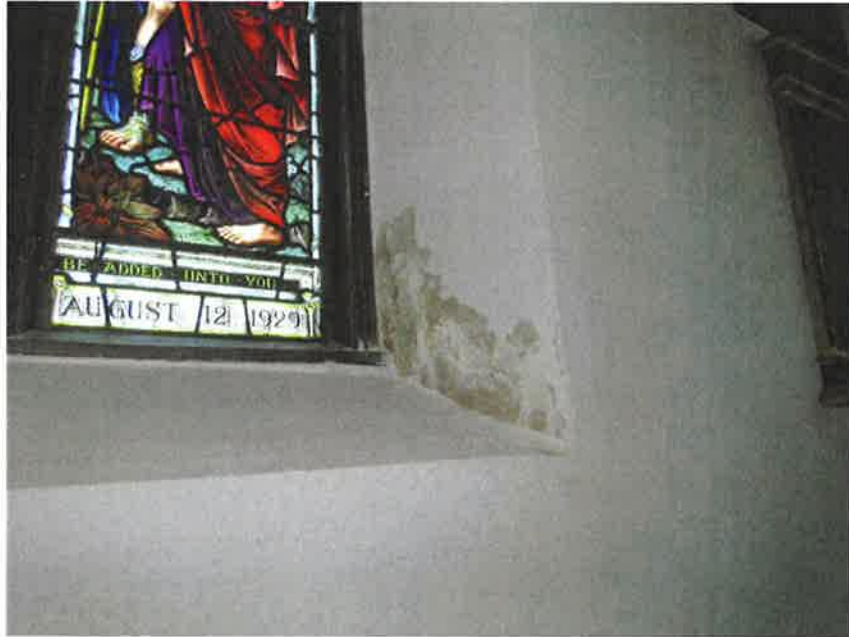
Photograph 19: White substance and stains on the east wall of the church around the stained glass window.

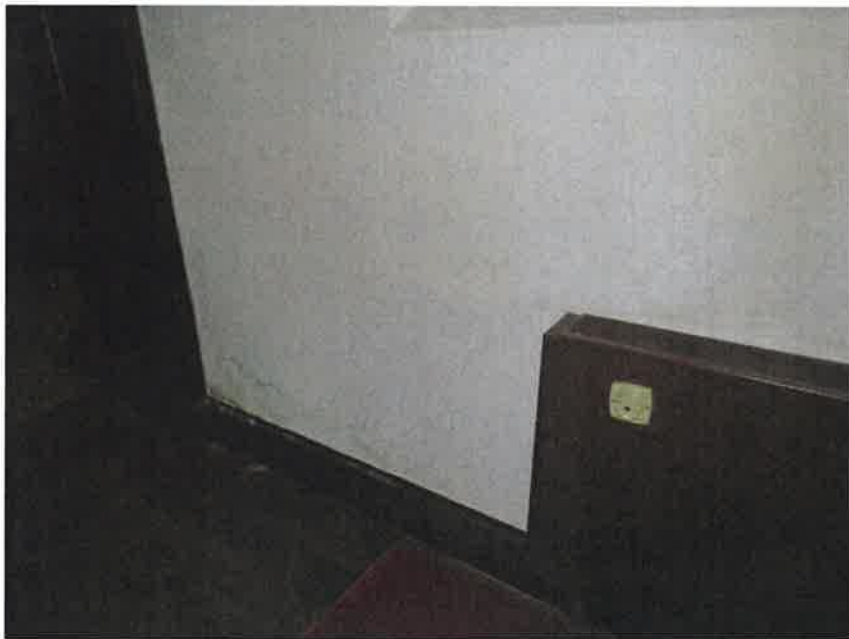
Photograph 20: White substance and stains on the north wall of the church.

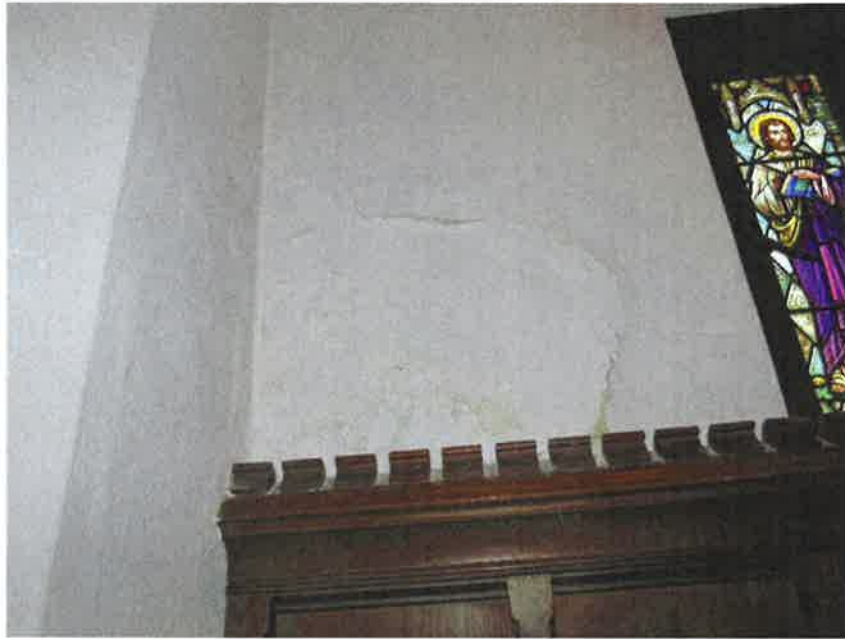
Photograph 21: White substance and stains on the west wall of the altar.

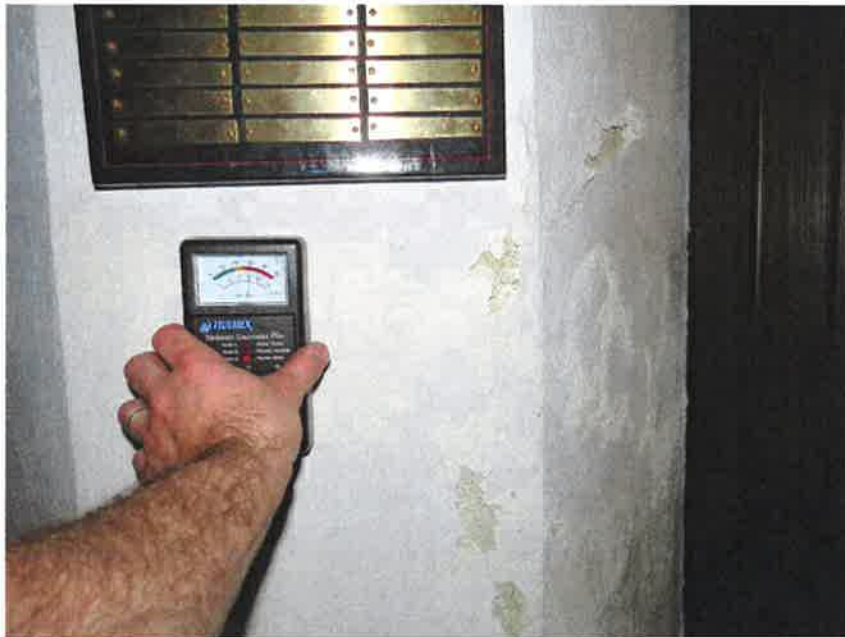
Photograph 22: White substance and stains on the altar's east wall, the reported bell tower's floor drain is within this wall.

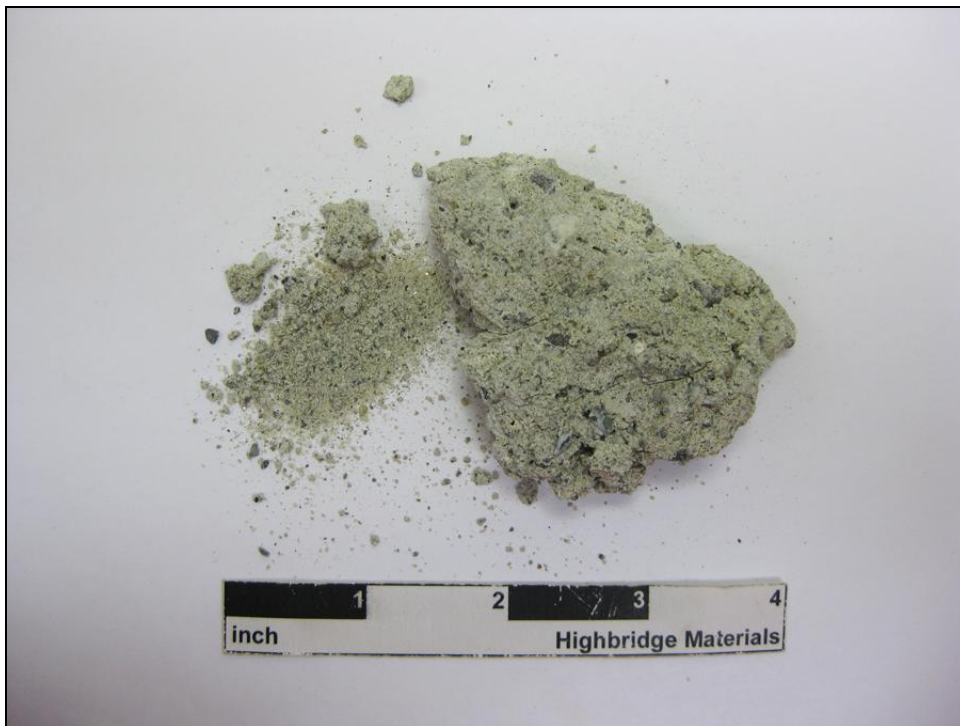
**Figure 1:** Photograph of the examined mortar sample provided to Highbridge for examination. The mortar has a uniform appearance with a light gray color. The cured product is cohesive, but the paste is moderately soft and highly permeable. There are also some hairline cracks visible in the sample piece.

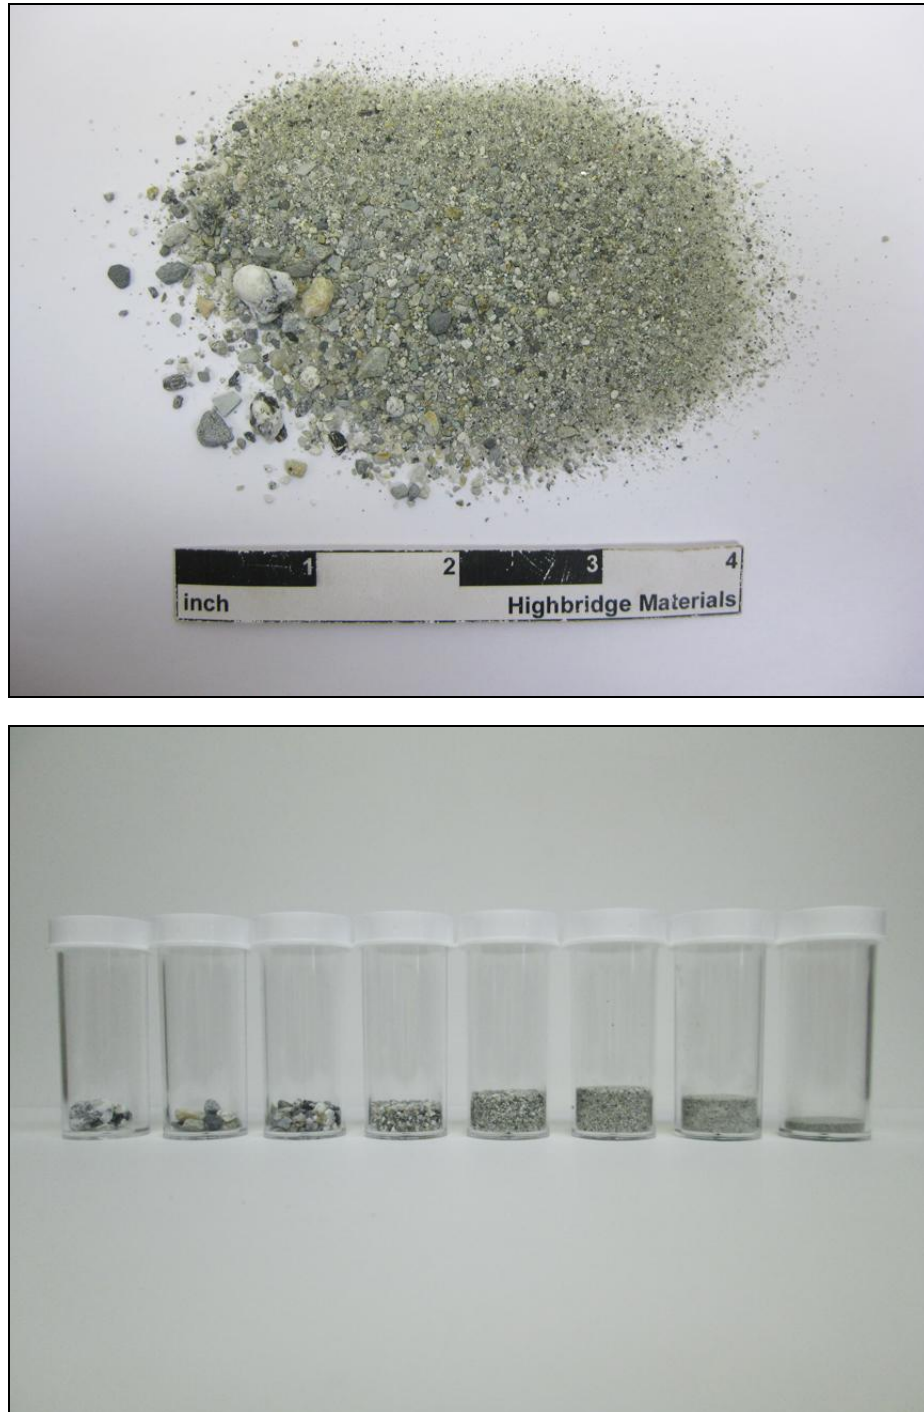
**Figure 2:** Photographs of the sand sample extracted through acid digestion. (Upper image) The complete extraction is shown. The sand has a moderately variegated appearance consisting of semi-translucent to semi-opaque grains with a light gray color overall. (Lower image) The extracted sand is shown after gradation through a standard sieve stack. The aggregate is broadly graded with a nominal top size at the No. 4 mesh and a peak abundance between the No. 50 and No. 100 sieves. Despite the broad gradation, the aggregate is not compliant with the limits specified by ASTM C144 for modern masonry sands.

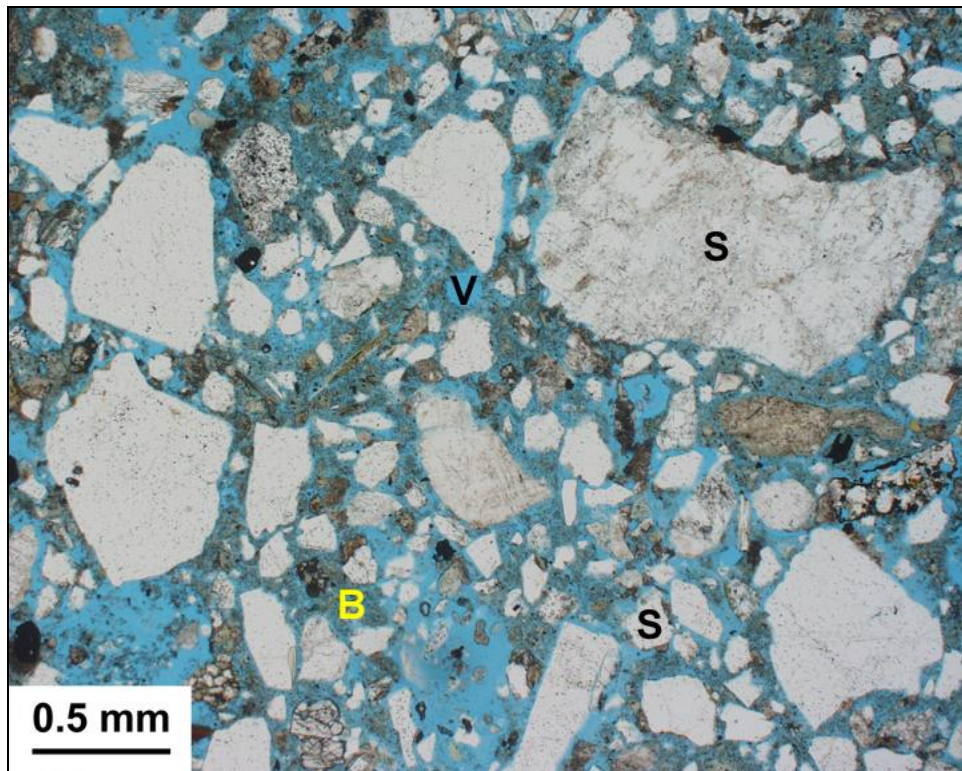
**Figure 3:** PPL photomicrograph illustrating the overall microtexture of the mortar. The sample is impregnated with a low-viscosity, blue-dyed epoxy in order to highlight cracks, pores, and voids. The binder matrix (B) is homogeneously developed with a high capillary porosity as indicated by the absorption of the dyed epoxy. The sand (S) is somewhat sharp-textured and densely distributed throughout the binder matrix. The mortar is compact and well consolidated with a total air-void content (V) estimated at 3-5% by volume.

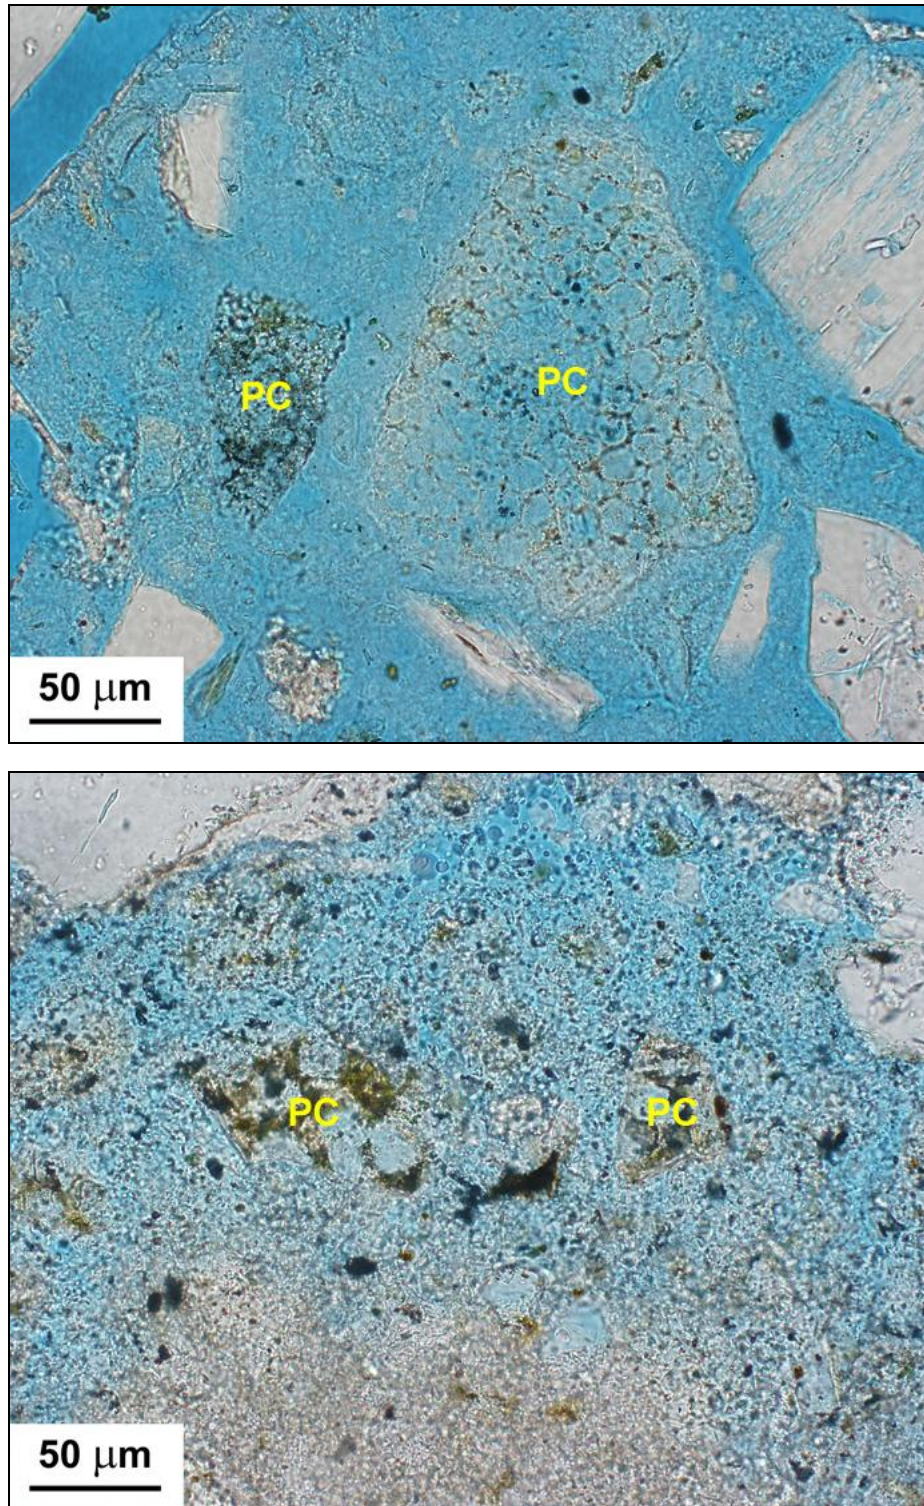
**Figure 4:** PPL photomicrographs illustrating the binder residuals in the examined mortar. The binder is cement-rich, and residual portland cement grains (PC) are present in moderate abundance. The cement is fully hydrated with residuals present as former calcium silicate agglomerates that are mostly defined by the interstitial iron-bearing ferrite. The ferrite identifies the cement as a gray rather than white variety. The medium grind of the cement is most consistent with an early to mid-twentieth century product.

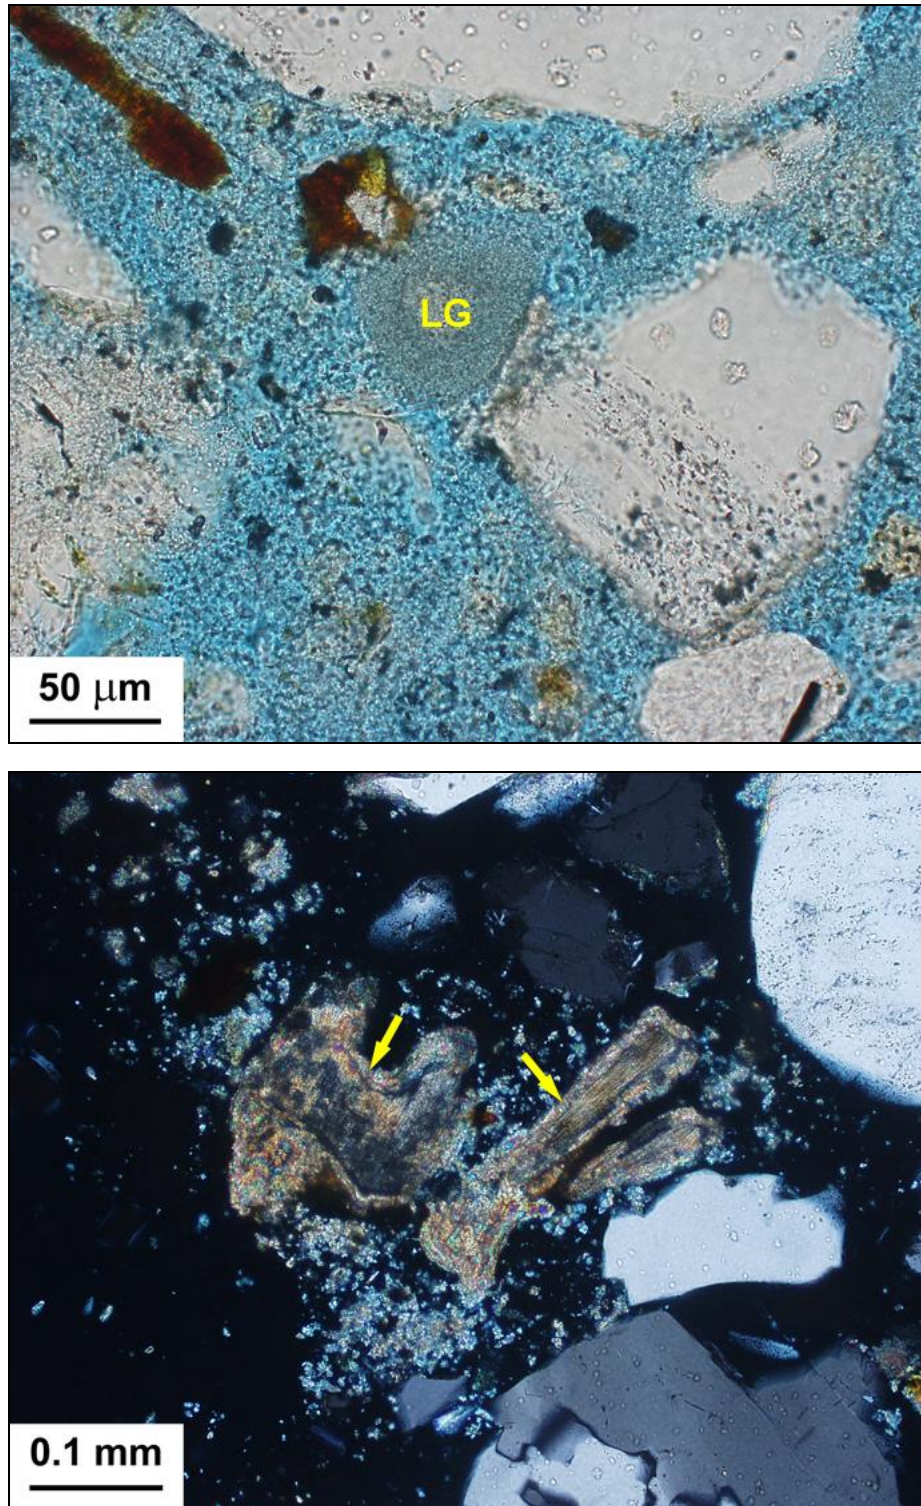
**Figure 5:** Photomicrographs illustrating the binder residuals in the examined mortar. (Upper PPL image) Though there are no clearly discernible undispersed lime particles, there is a single potential lime grain (LG) detected in thin section. This is internally nondescript and approximately 75 µm in diameter. (Lower XPL image) There are also trace residuals of fired silicates (arrows) dispersed throughout the binder matrix. These represent impurities in the original source rock that were burned during the lime manufacturing process.

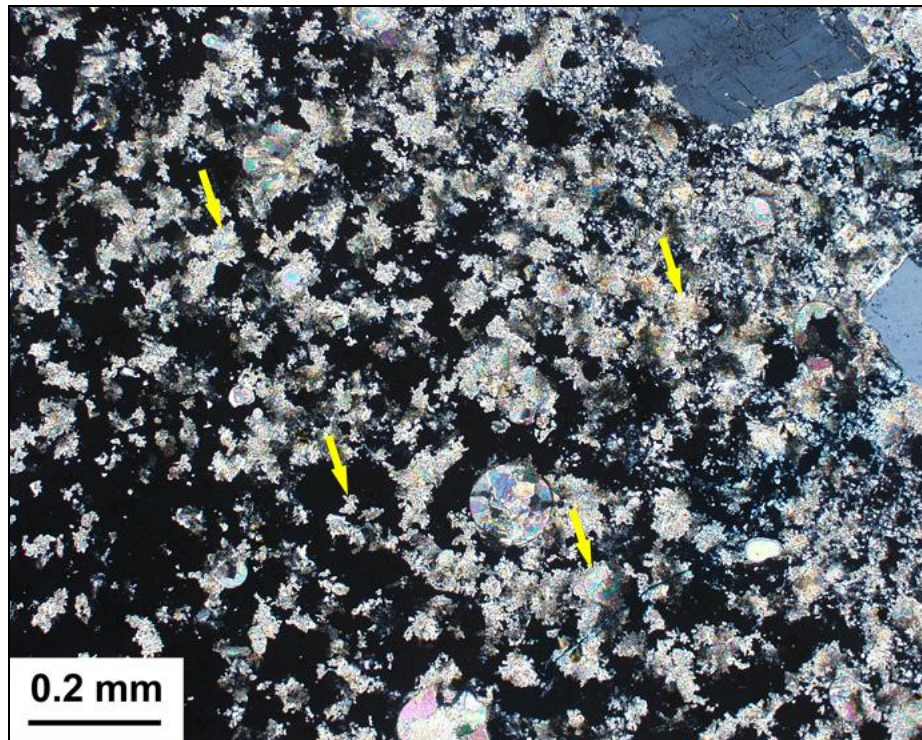
**Figure 6:** XPL photomicrograph illustrating secondary service effects in the mortar sample. A bicarbonation reaction appears to have occurred, resulting in an isotropic binder matrix with patchy, "popcorn-like" areas of carbonation (arrows). This typically occurs when the binder paste is relatively porous and calcium hydroxide has been depleted, allowing for the movement of more acidic pore water that digests calcium from the matrix and precipitates it as patches of calcium carbonate.

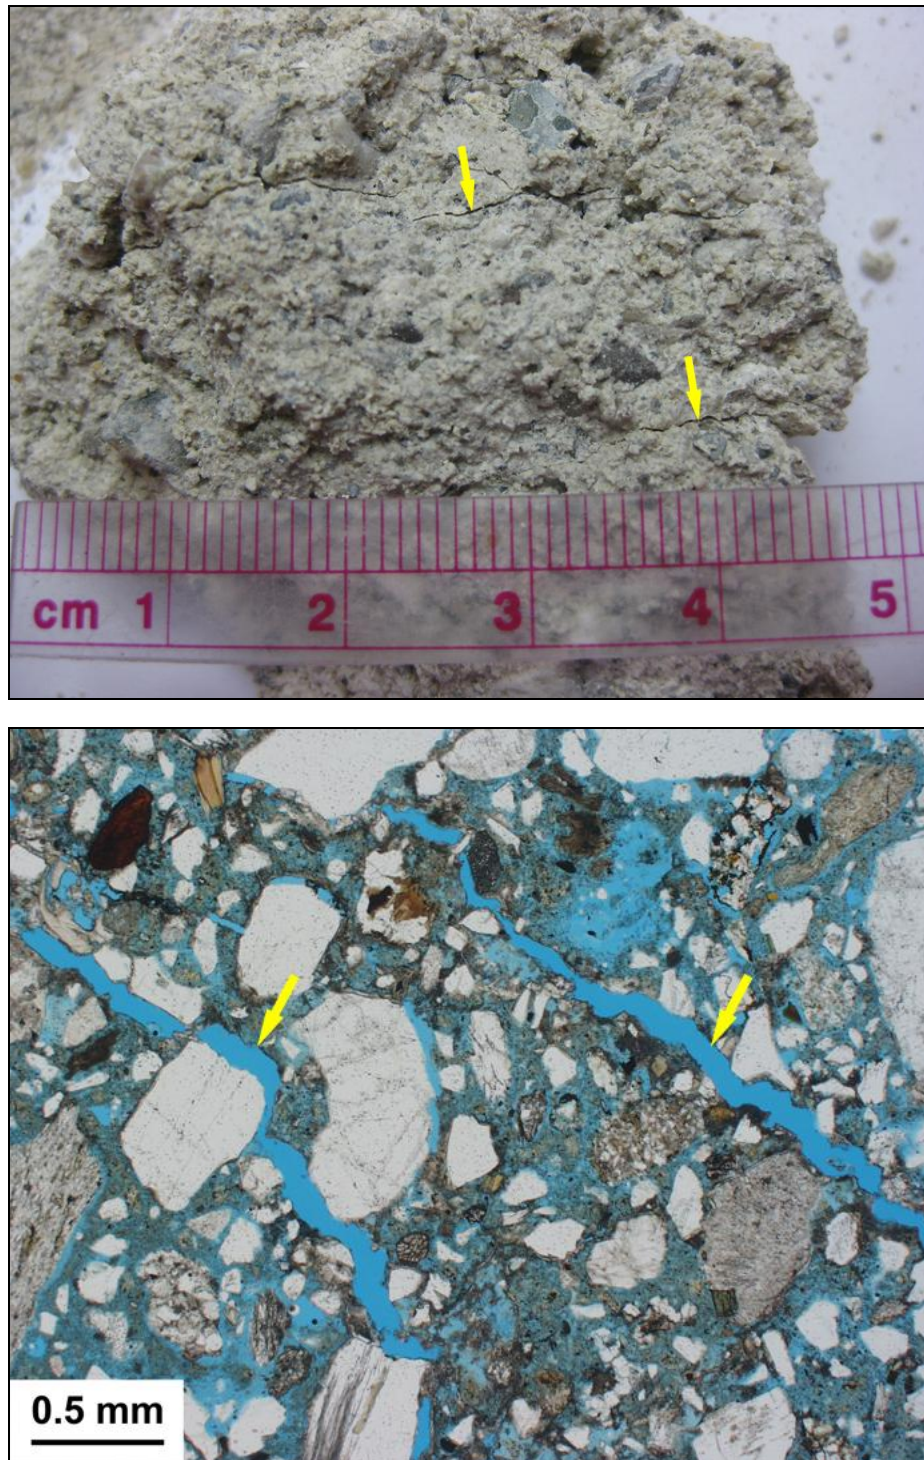
**Figure 7:** Images illustrating secondary cracking in the mortar sample. (Upper photograph) The cracking (arrows) is visible in the hand sample at as parallel cracks spaced at the centimeter scale. (Lower PPL photomicrograph) When viewed at the polarized light microscope, the cracks (arrows) are present in moderate abundance and sometimes spaced roughly a millimeter apart. These are mostly parallel to one another and meander through the paste, deflecting around aggregate particles. The characteristics of these cracks are consistent with freeze-thaw distress.

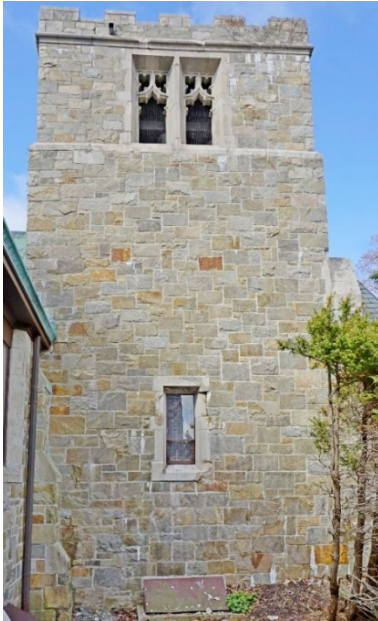
Tower – East wall

Masonry joints mostly cracked; this wall was covered with Ivy. The window surrounds and limestone bands are all damaged. Moisture damage is increasing rapidly. Our estimate includes rebuilding this whole side

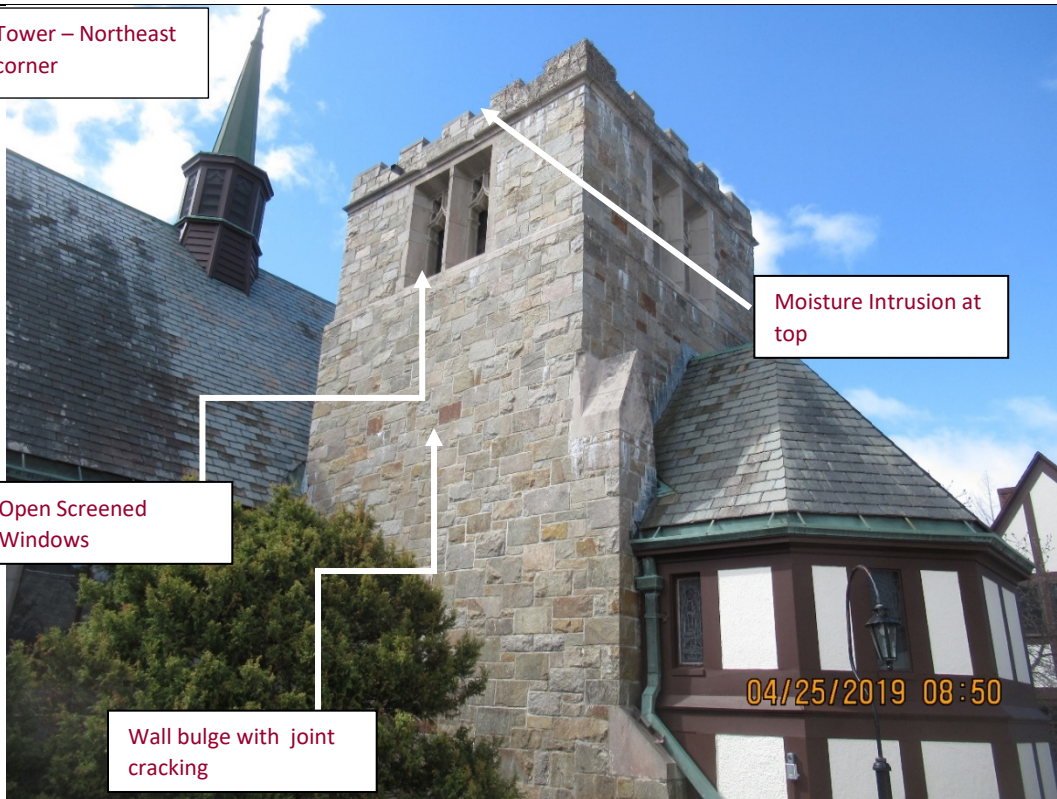
**Photo 02**  
Northeast  
Tower

Moisture Intrusion at  
top

Open Screened  
Windows

Wall bulge with joint  
cracking
