St. Thomas' Vestry  
 East Elevation and Bell Tower Repairs/Restoration - Summary  
 March 15, 2020/February 6, 2022 (updated)

*The following historical summary was initially prepared in March of 2020 (pages 1 and 2) and has been updated for the subsequent evaluation of alternatives to repair the Bell Tower (pages 3 and 4).*

**Church Insurance Company of Vermont**  
**Claim Number: 35080**  
**May 23, 2017**  
**Page 9**

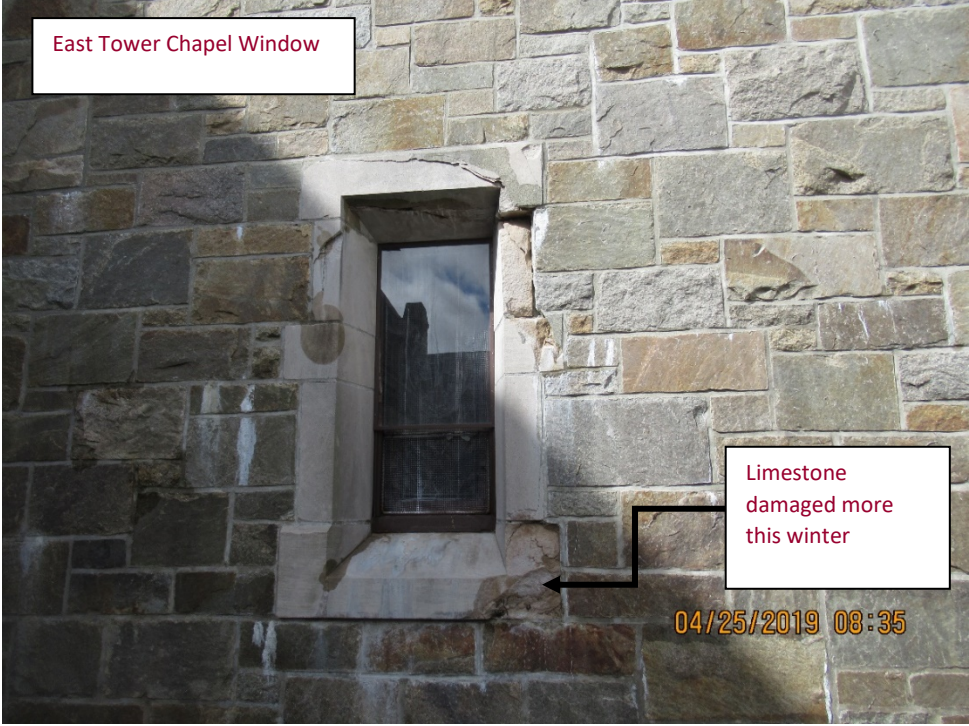
| <p>East Tower Chapel Window</p> <p>Limestone damaged more this winter</p> <p>04/25/2019 08:35</p> | <p><b>Photo 04</b><br/>East Chapel Window</p> |

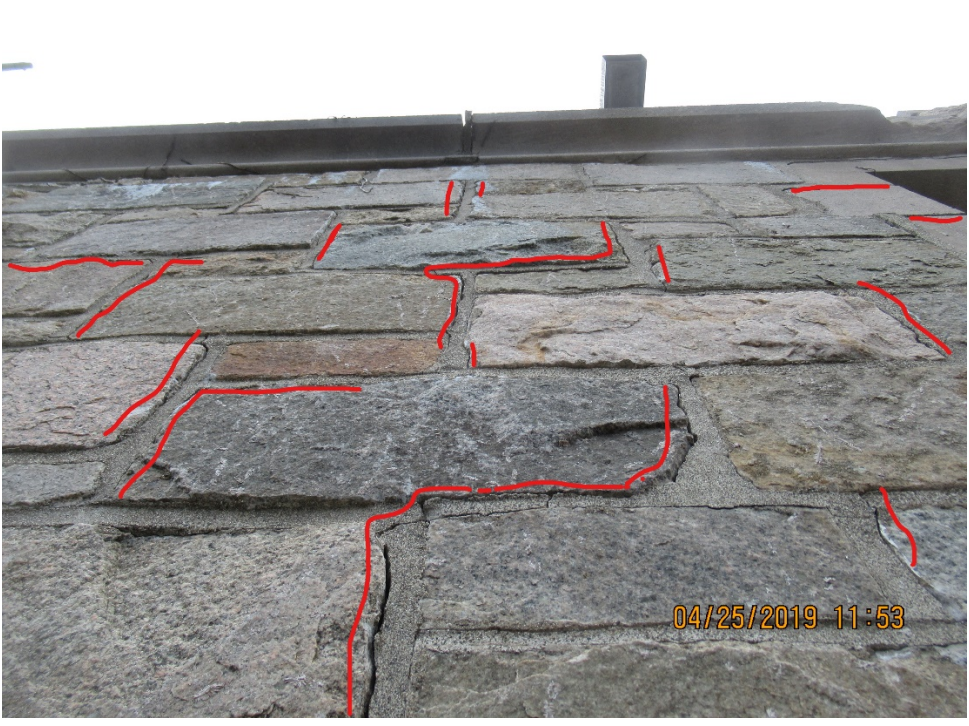
| <p>04/25/2019 11:53</p> | <p><b>Photo 05</b><br/>Mortar cracks at the SE corner of Tower, highlighted in red.</p> |

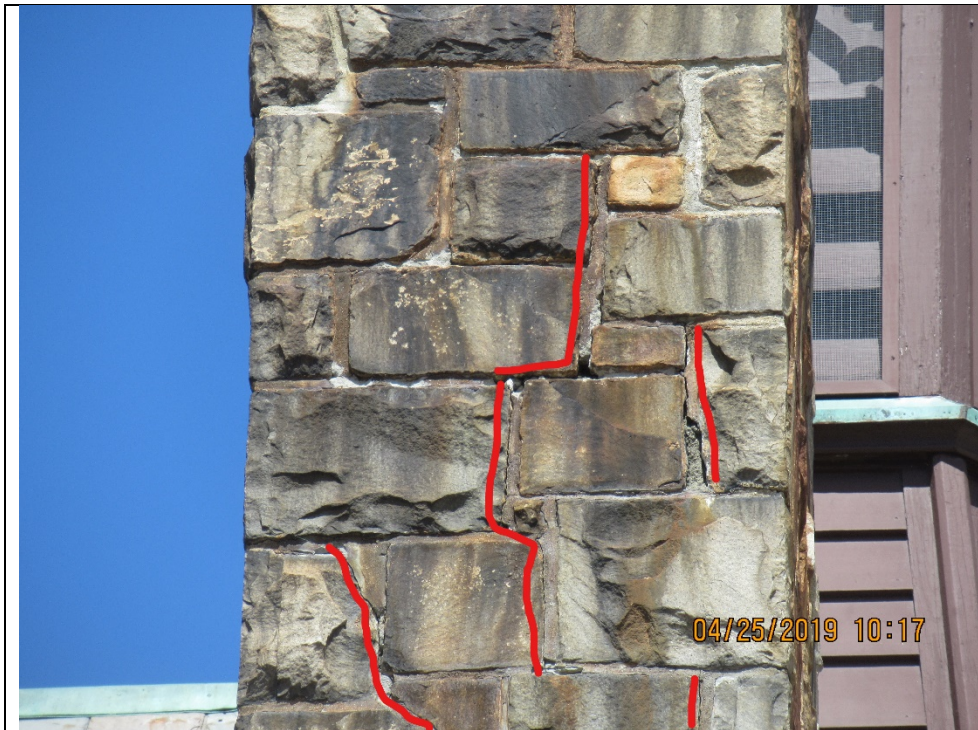
**Photo 06**

South Chimney face mortar joint cracks, note variety of mortar colors and textures.

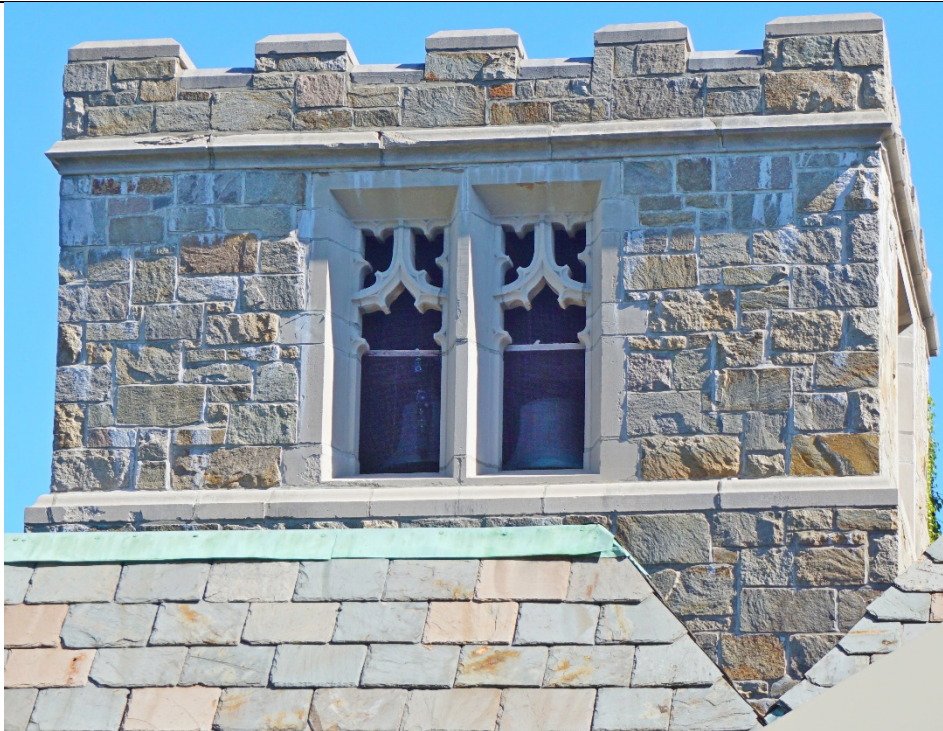
**Photo 07**

Window louvers have been removed on 3 sides allowing weather direct access to bell chamber.

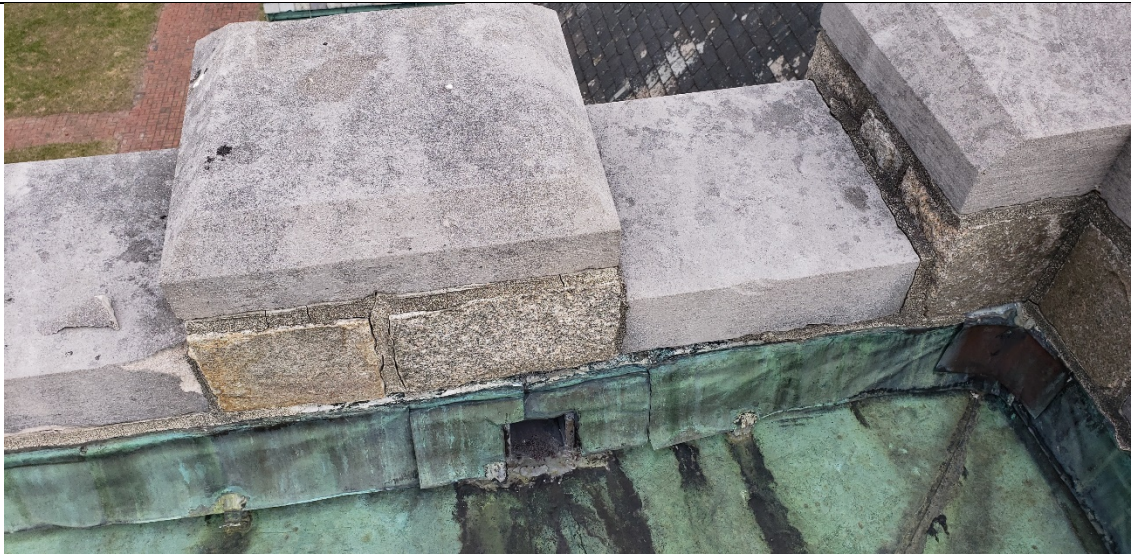
**Photo 08**  
Copper roof  
at scupper  
and view of  
crenellation  
caps. Note  
cracked  
mortar  
joints.

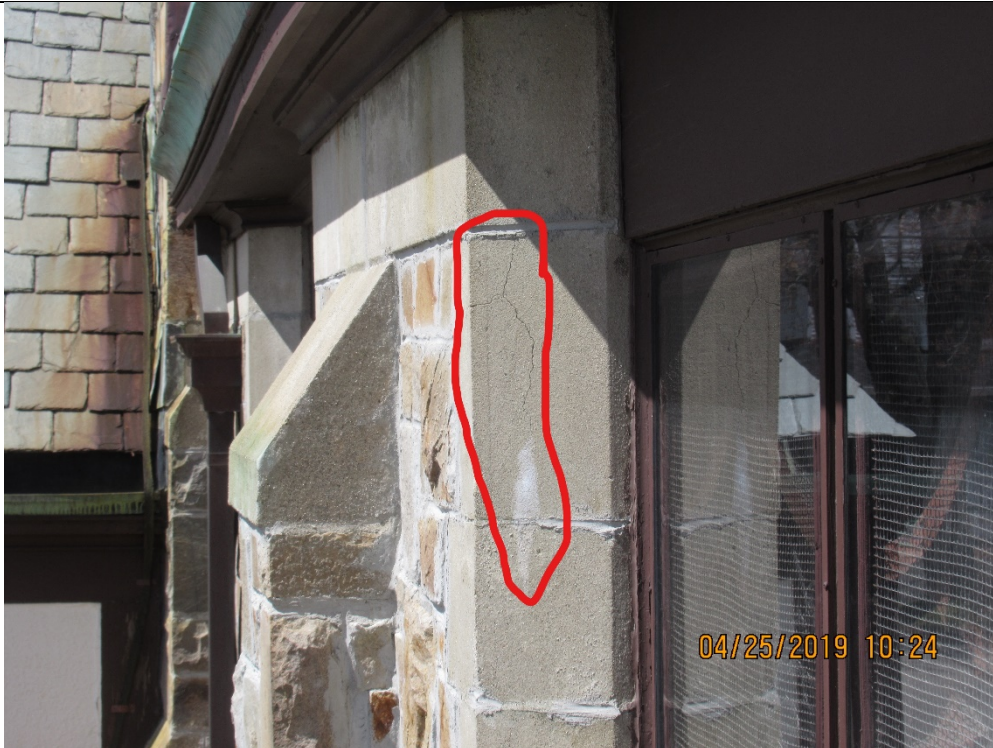
**Photo 09**  
Nave  
window  
surround  
cracks and  
wood trim to  
stone joint  
gap.

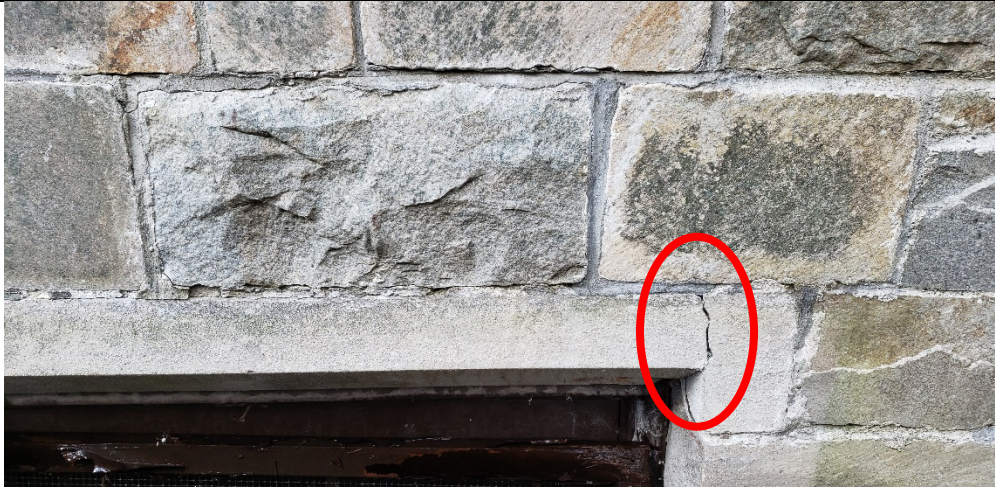
**Photo 10**  
Limestone  
window  
crack

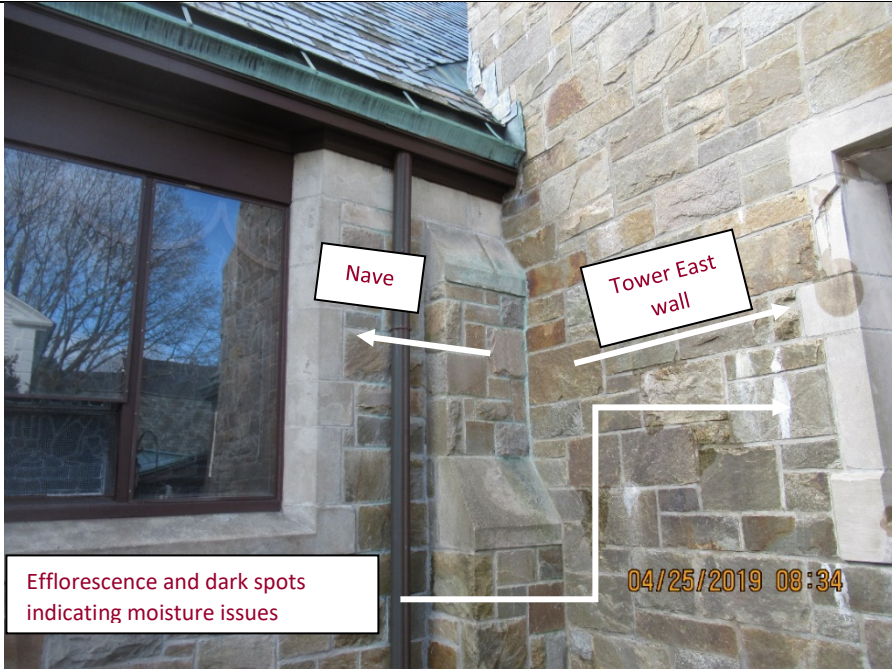
**Photo 11**  
East Tower /  
Nave corner  
Note this  
area has  
interior  
plaster  
damage.

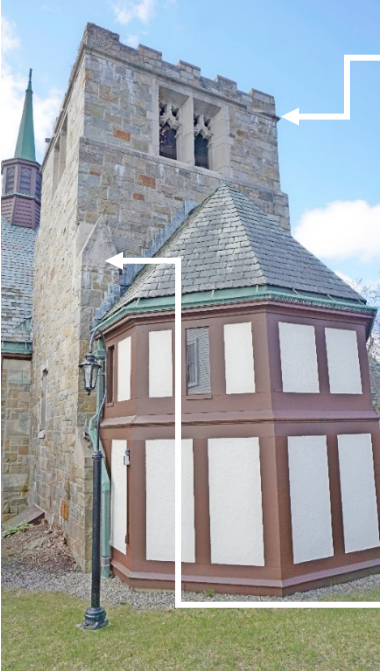
| <p>Damaged Limestone cornice</p> <p>Heavy efflorescence at cap</p> | <p><b>Photo 12</b><br/>North Tower</p> |

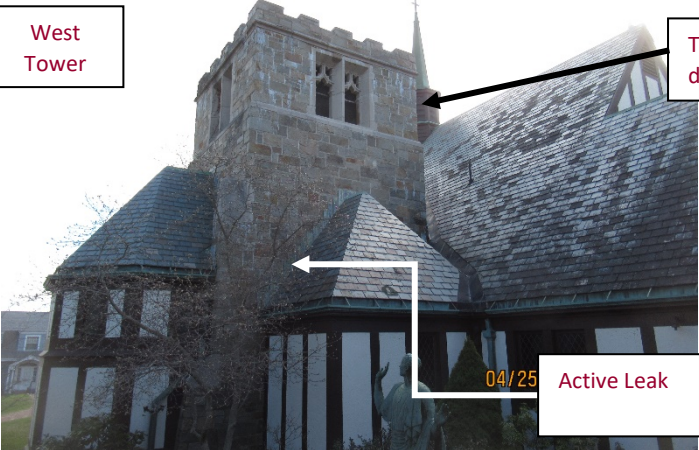
| <p>West Tower</p> <p>Top heavily moisture damaged</p> <p>04/25 Active Leak</p> | <p><b>Photo 13</b><br/>West Tower</p> |

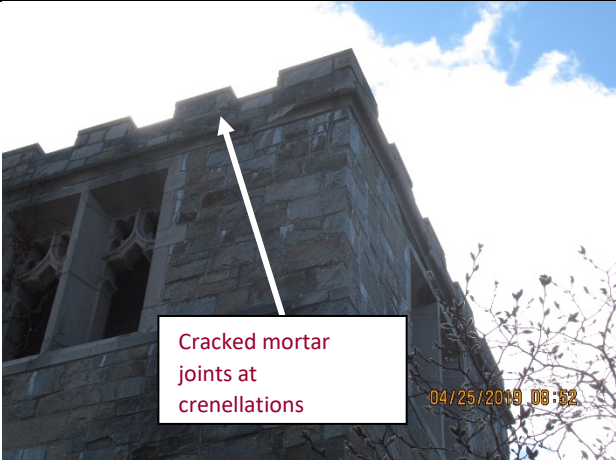
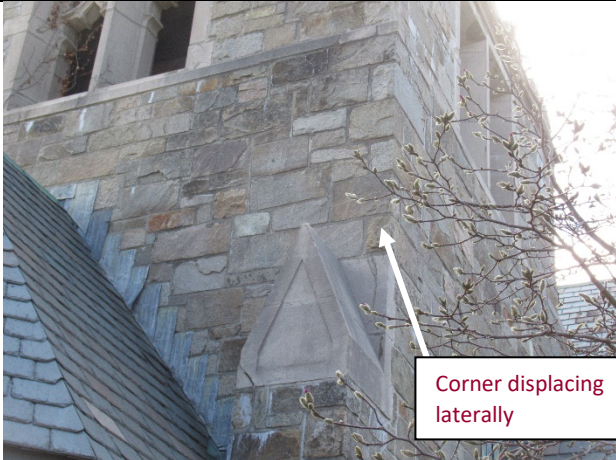
| <p>Cracked mortar joints at crenellations</p> <p>04/25/2019 08:52</p> | <p>Corner displacing laterally</p> | <p><b>Photo 16</b><br/>North Tower</p> |

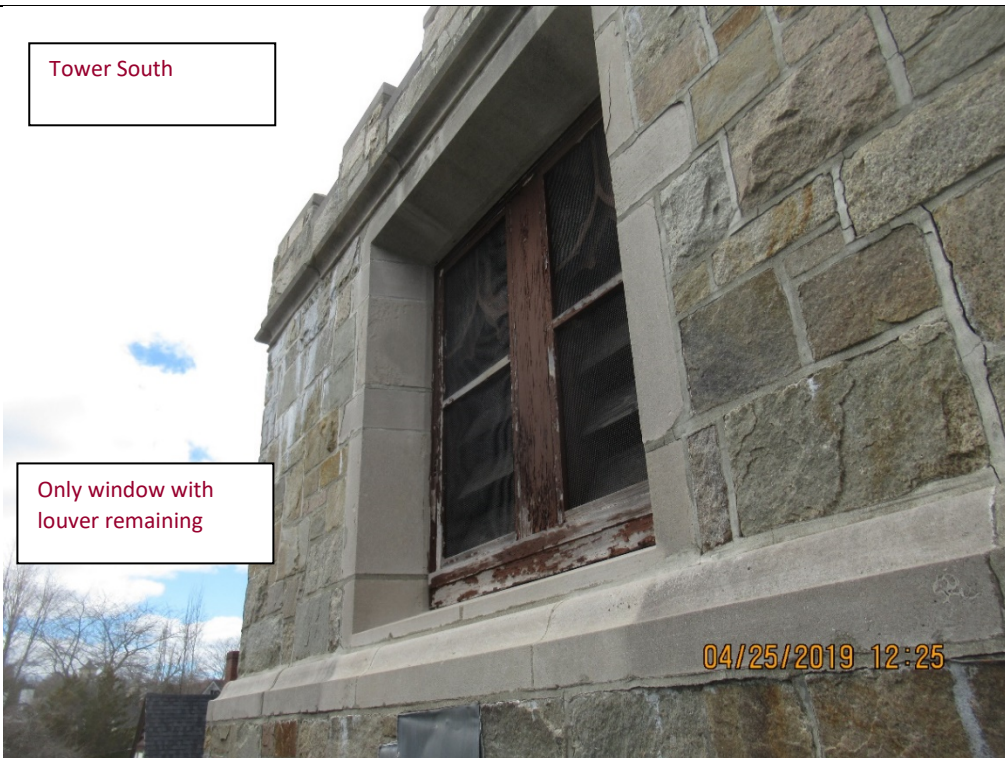
| <p>Tower South</p> <p>Only window with louver remaining</p> <p>04/25/2019 12:25</p> | <p><b>Photo 17</b><br/>South Tower</p> | |

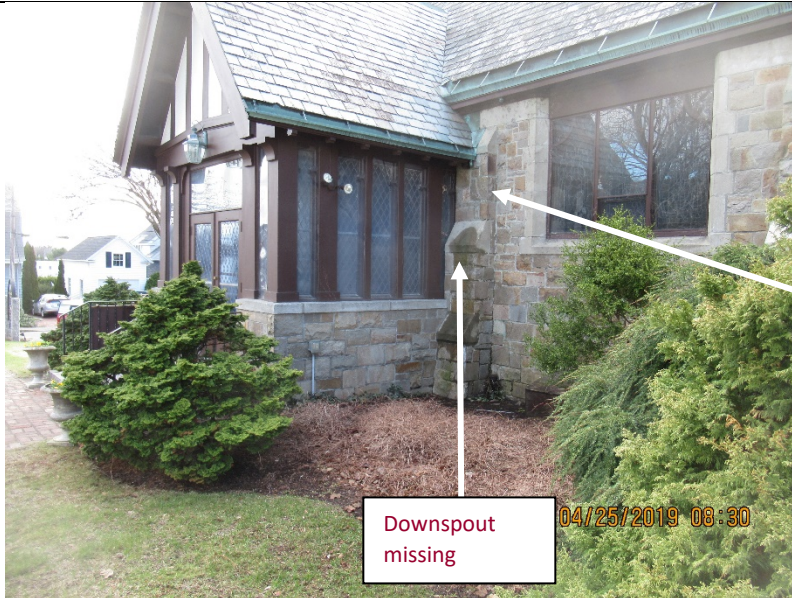
**Photo 19**  
Maintenance  
issue

Mortar joint step  
cracks

Downspout  
missing

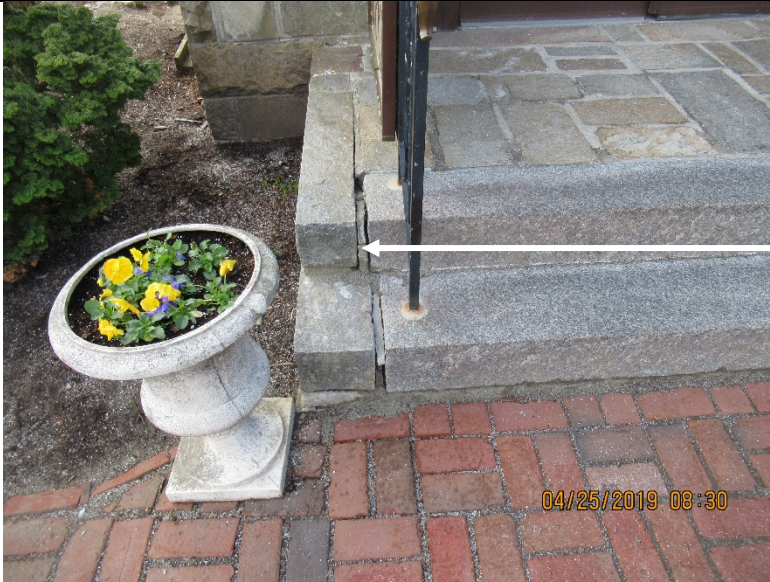
**Photo 20**  
Entrance  
steps

Loose mortar

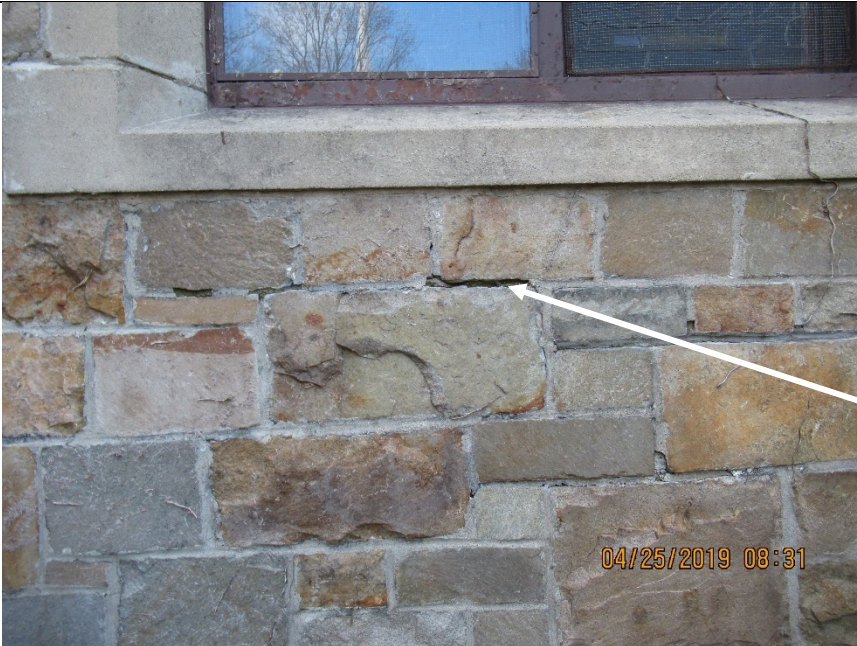
**Photo 21**  
Nave mortar  
repairs

Poor Mortar joint  
repair

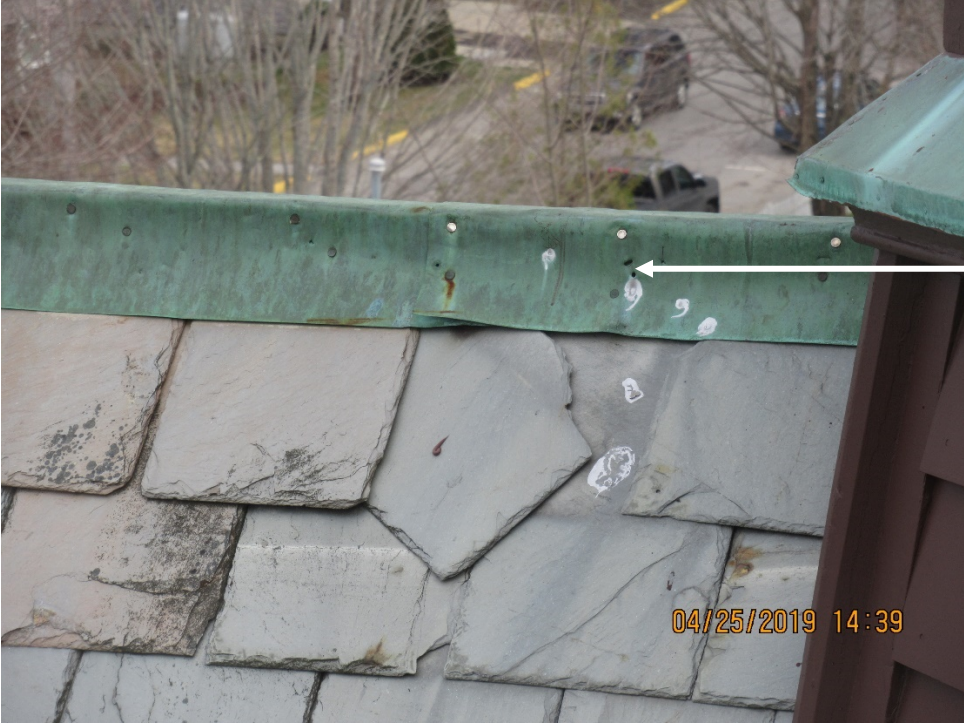
| | <p><b>Photo 22</b><br/>Slate roof</p> <p>Repaired ridge cap<br/>with open nail holes<br/>and broken slate tile</p> | |

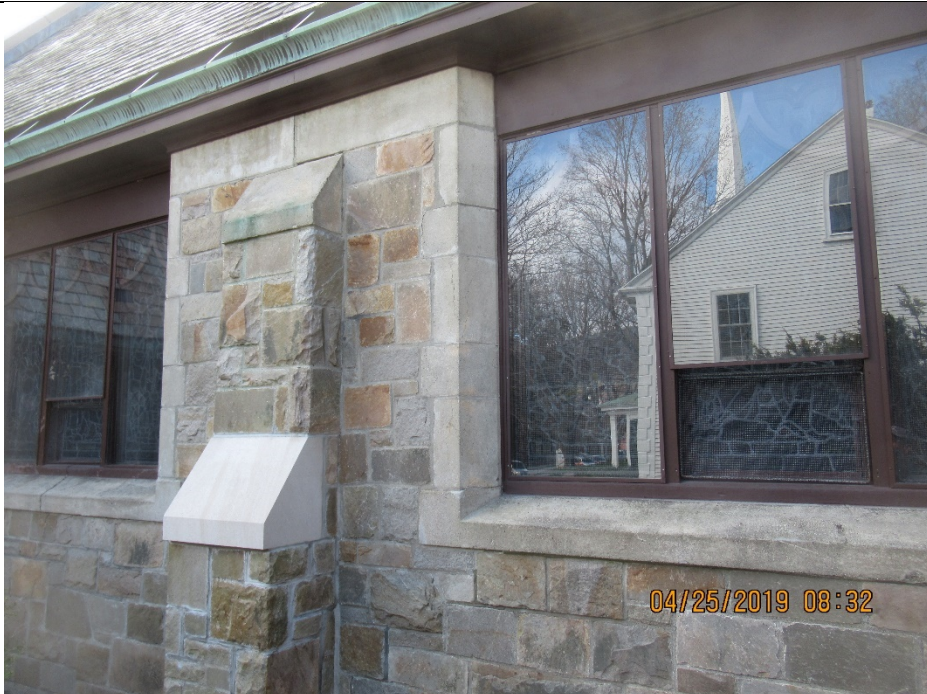
**Photo 25**  
Trim at  
window  
head is  
generally ok,  
ends and  
jambes near  
stone need  
work.

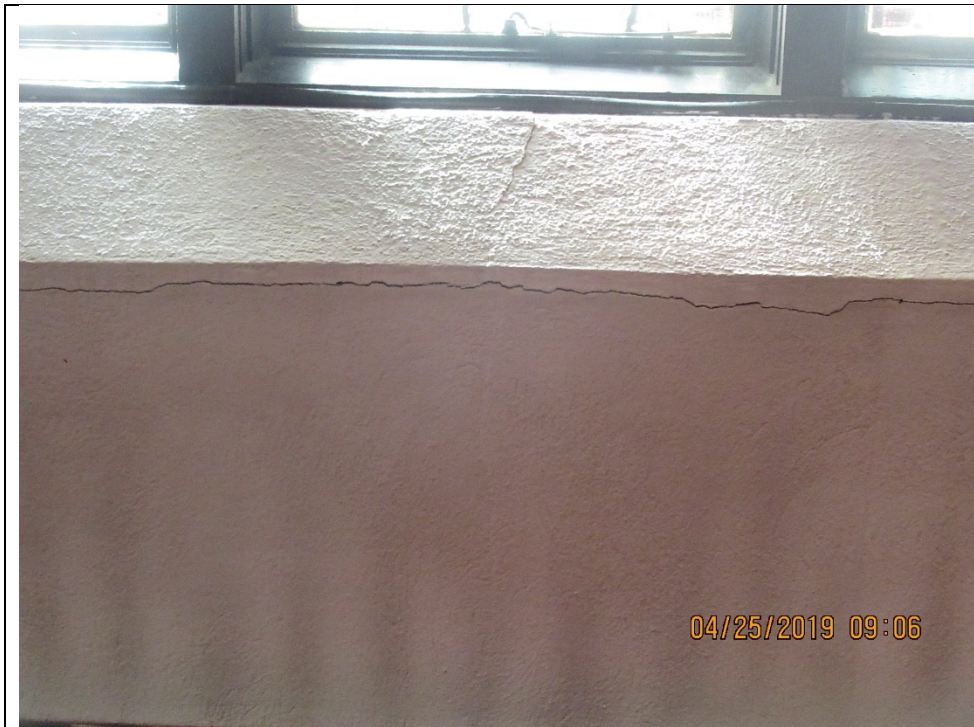
**Photo 26**  
Typical  
interior  
crack at  
windowsill

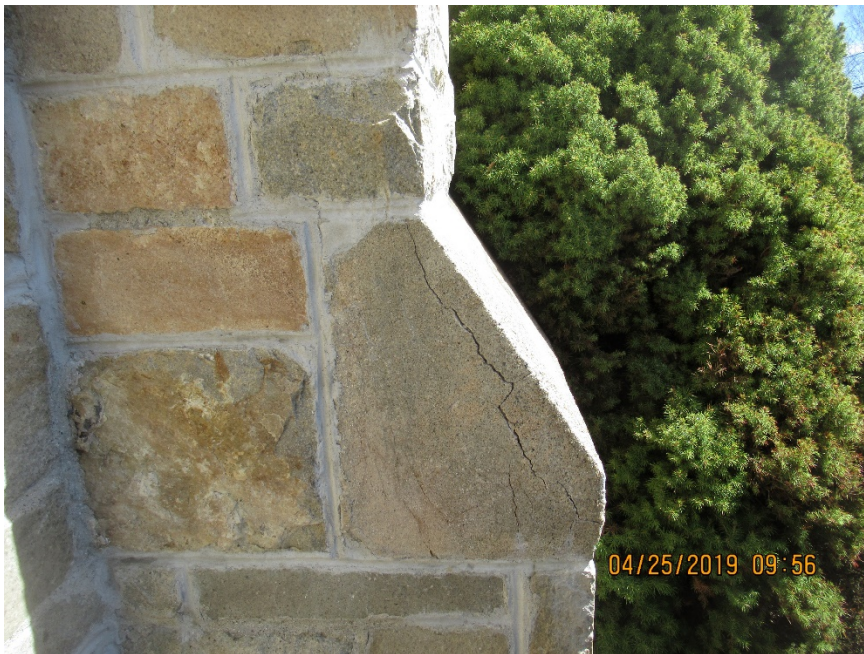
**Photo 27**  
Cracked Cap  
Stone
