Re: Masonry Tower & Roof Assessment and Design Documents

St. Thomas' Tower Repair Options
Building Envelope Specialists
Oct-19

BELL TOWER REPAIR OPINION OF PROBABLE COST

**RE: St. Thomas Church Bell Tower Repair
Opinion of Probable Cost**

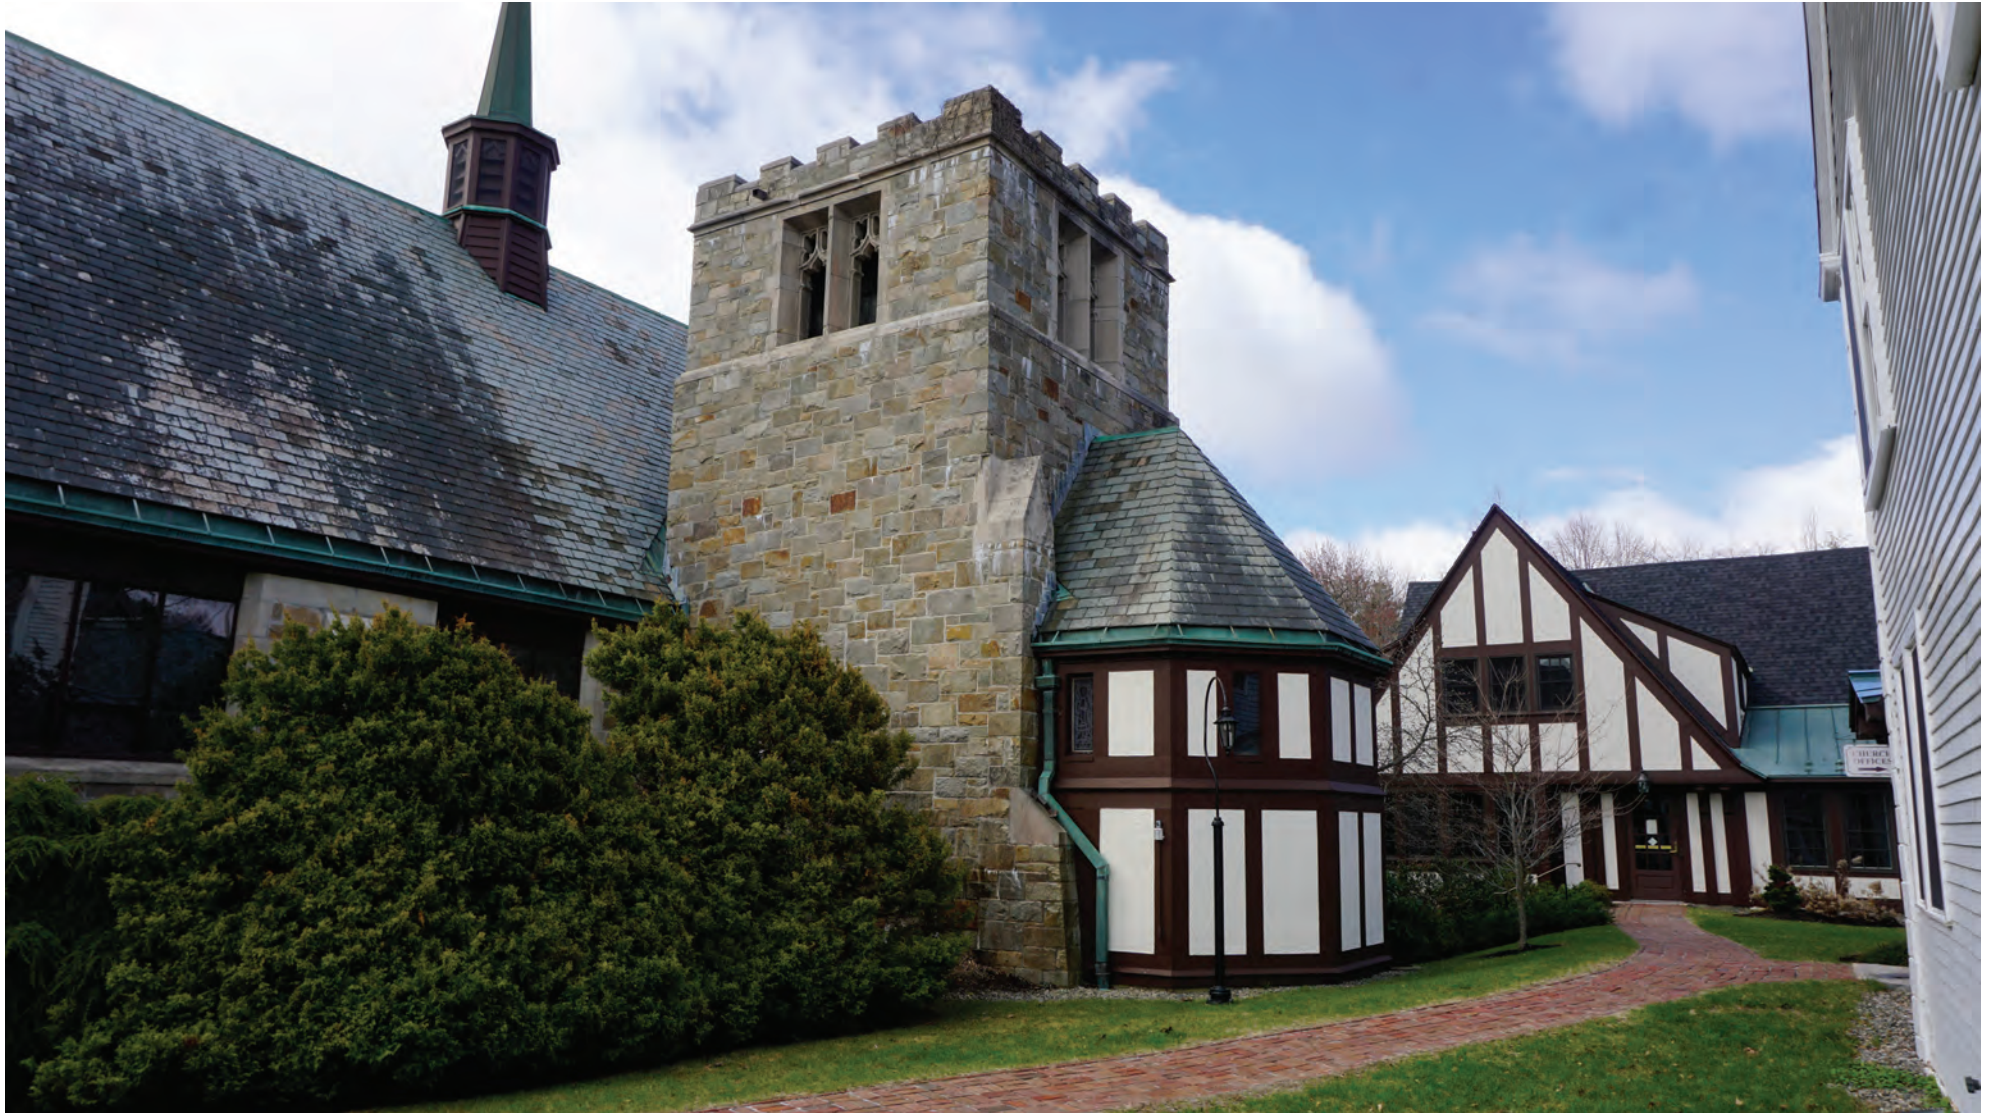
Option B

01 - Existing Tower + Low Roof Shingles

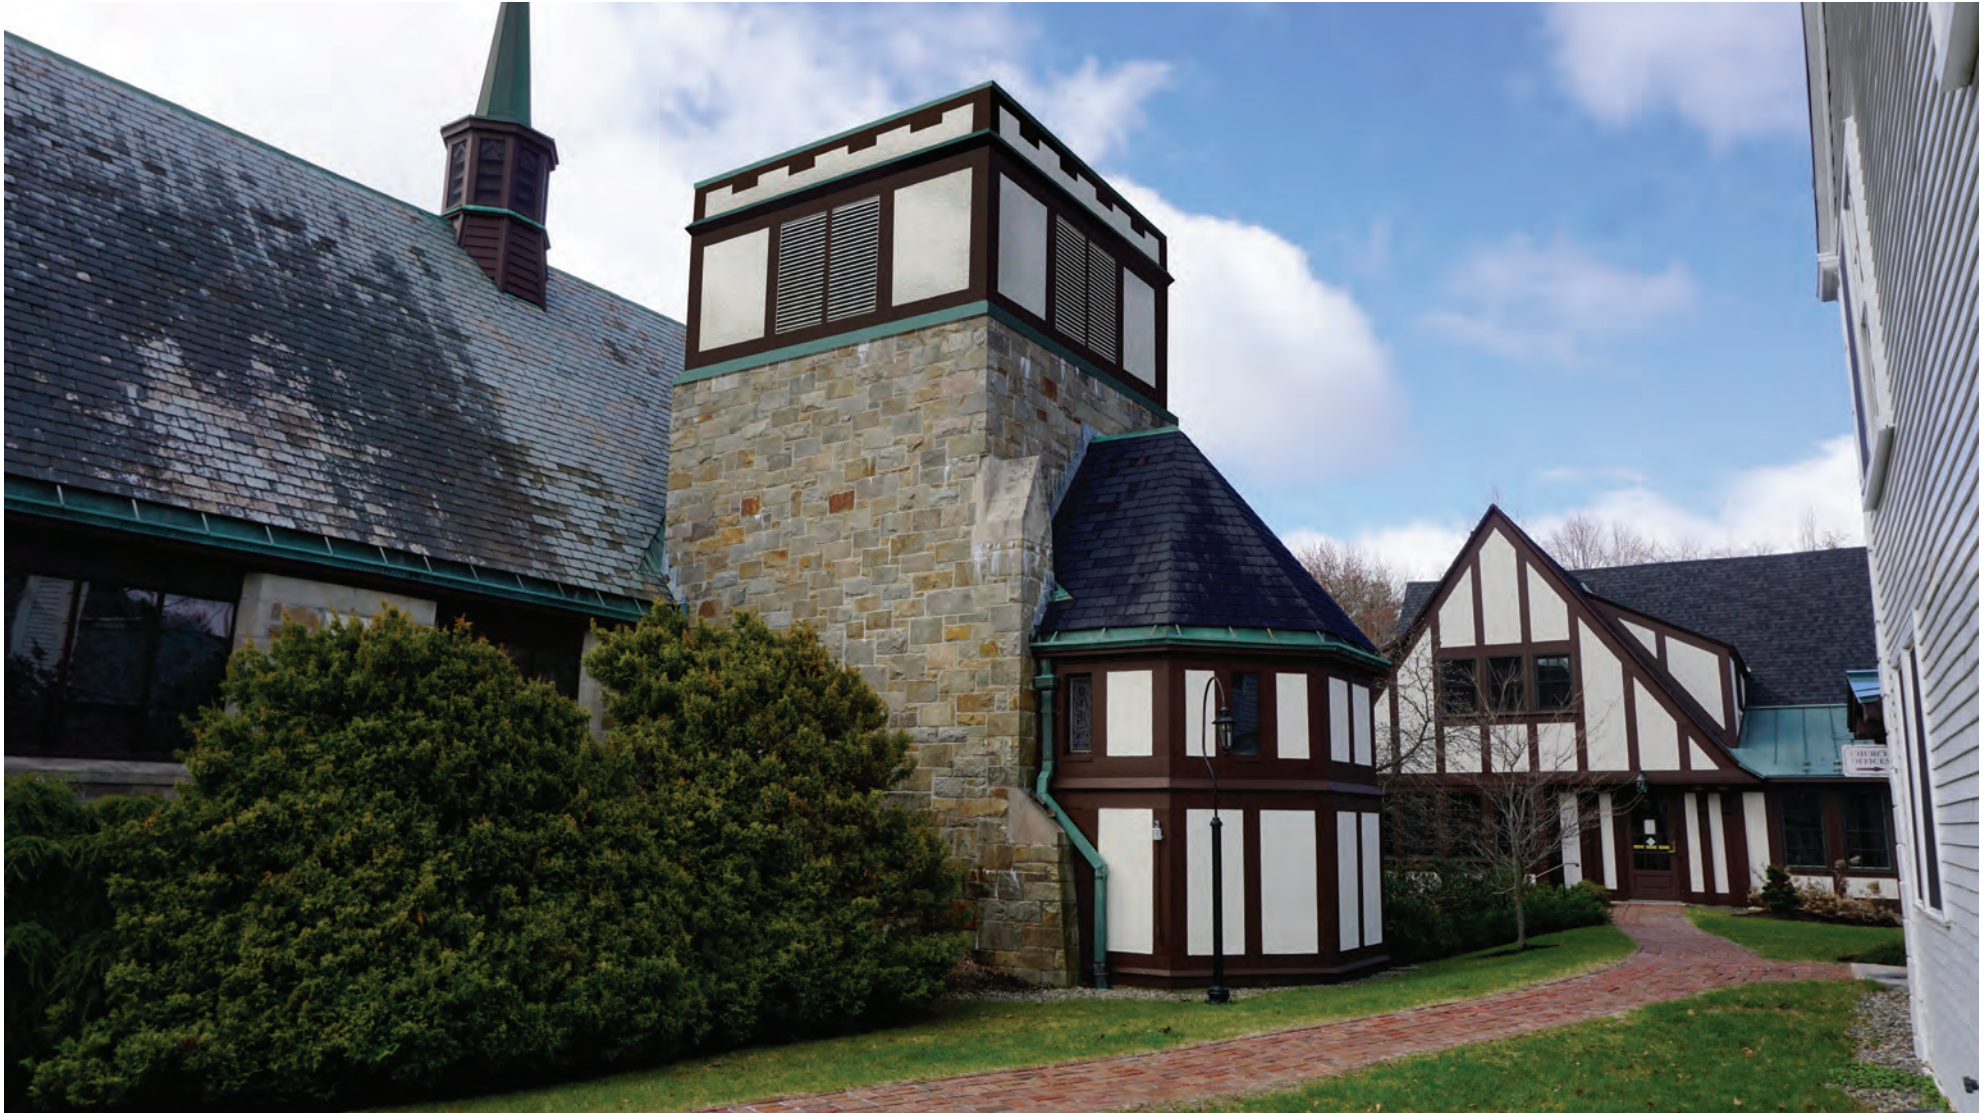
Option D

02 - No Tower with Lowered Crenellation

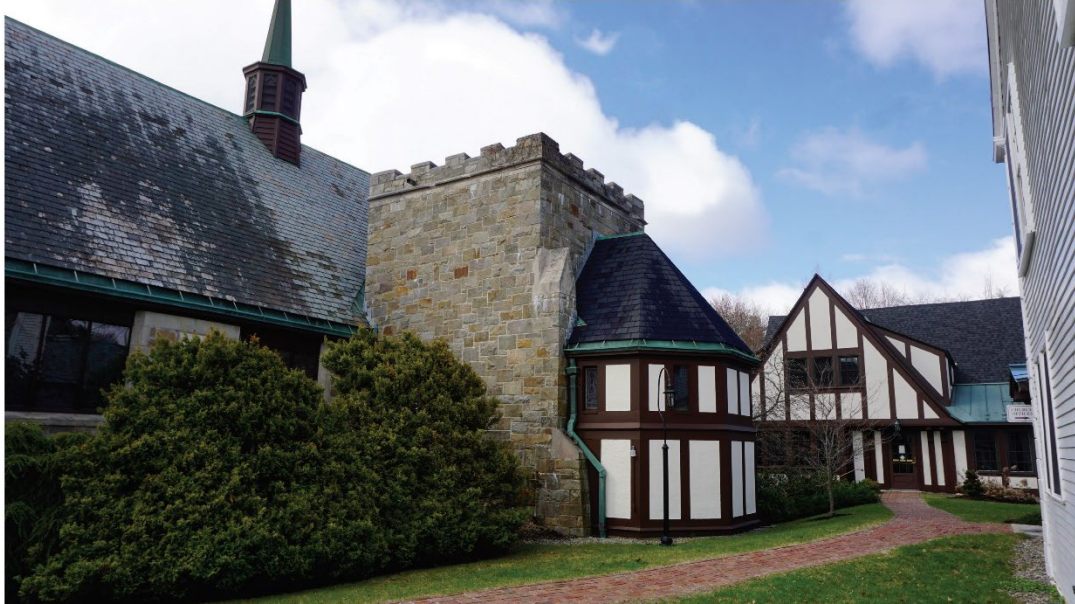
Option E

03 - Pyramid Hip Shingle roof with Copper Base Flashing

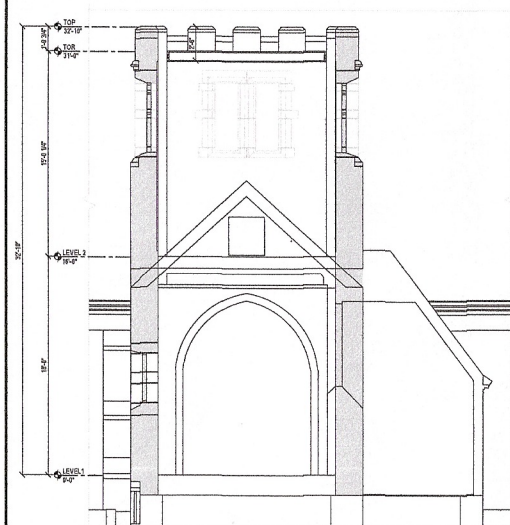
3 TOWER SECTION
1/8"=1'-0"

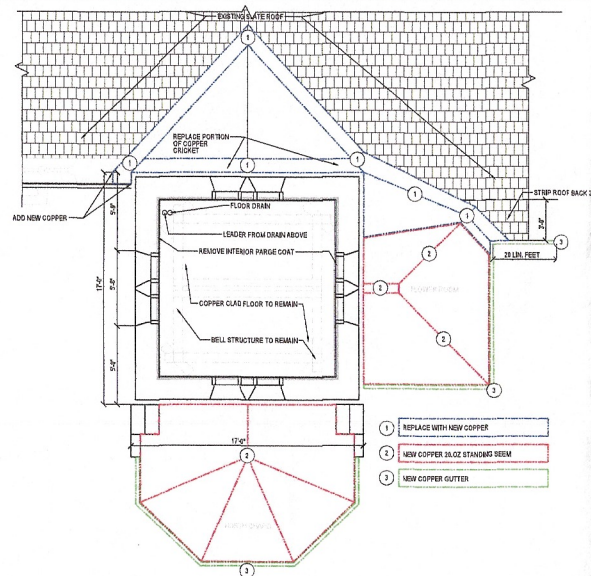
2 TOWER @ 2ND FLOOR AND ADJACENT ROOF WORK
1/8"=1'-0"

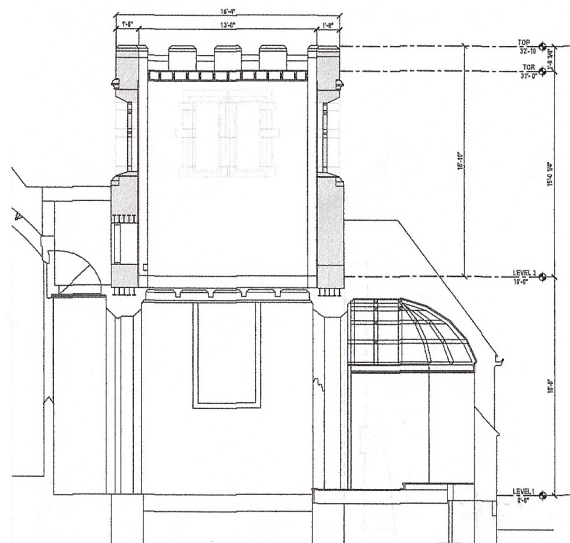
4 TOWER SECTION
1/8"=1'-0"

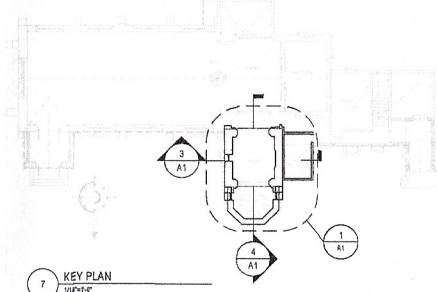
7 KEY PLAN
1/8"=1'-0"
